City of Darwin Coastal Erosion Management Plan

**Coastal Erosion Management
Plan**

Prepared For: City of Darwin

Prepared By: BMT WBM Pty Ltd (Member of the BMT group of companies)

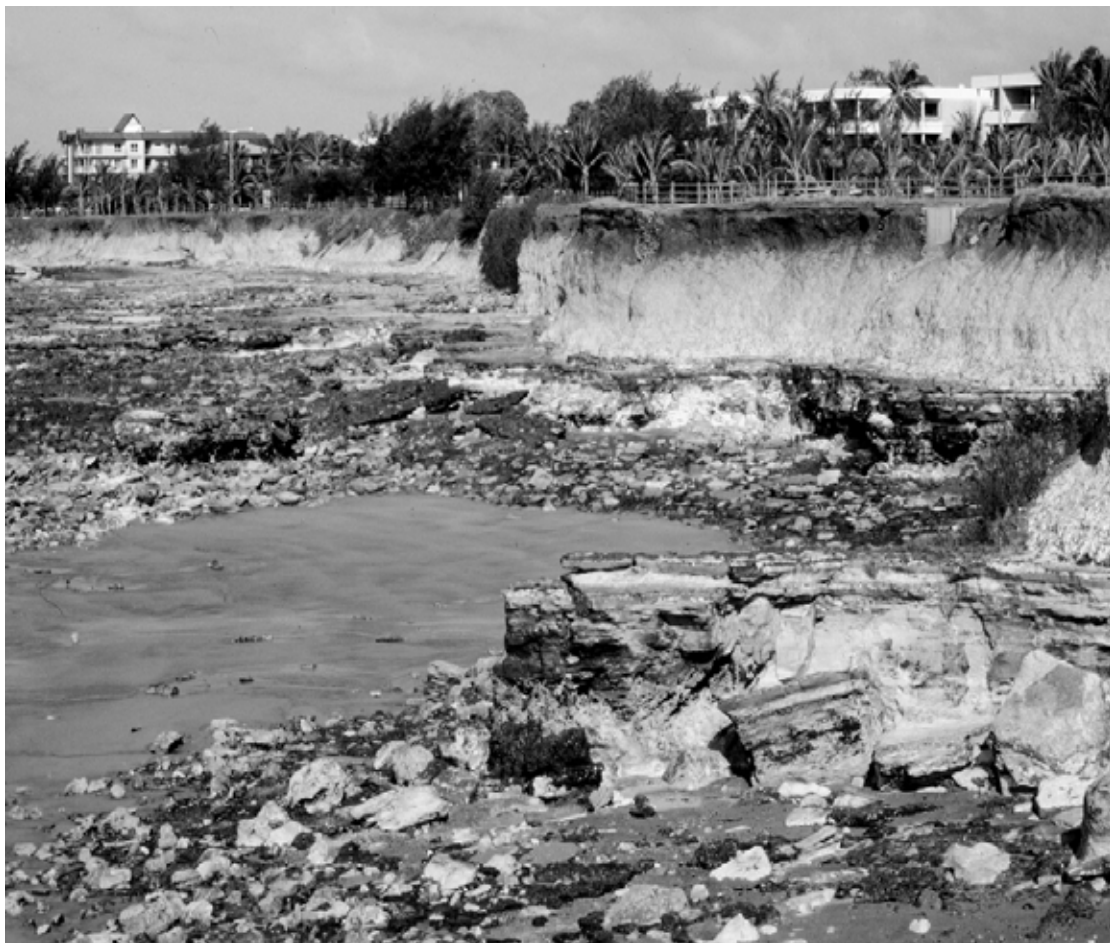
Figure 2-16 Typical Strata showing Saprolite above Cretaceous Shore Platform (from Nott 2003)

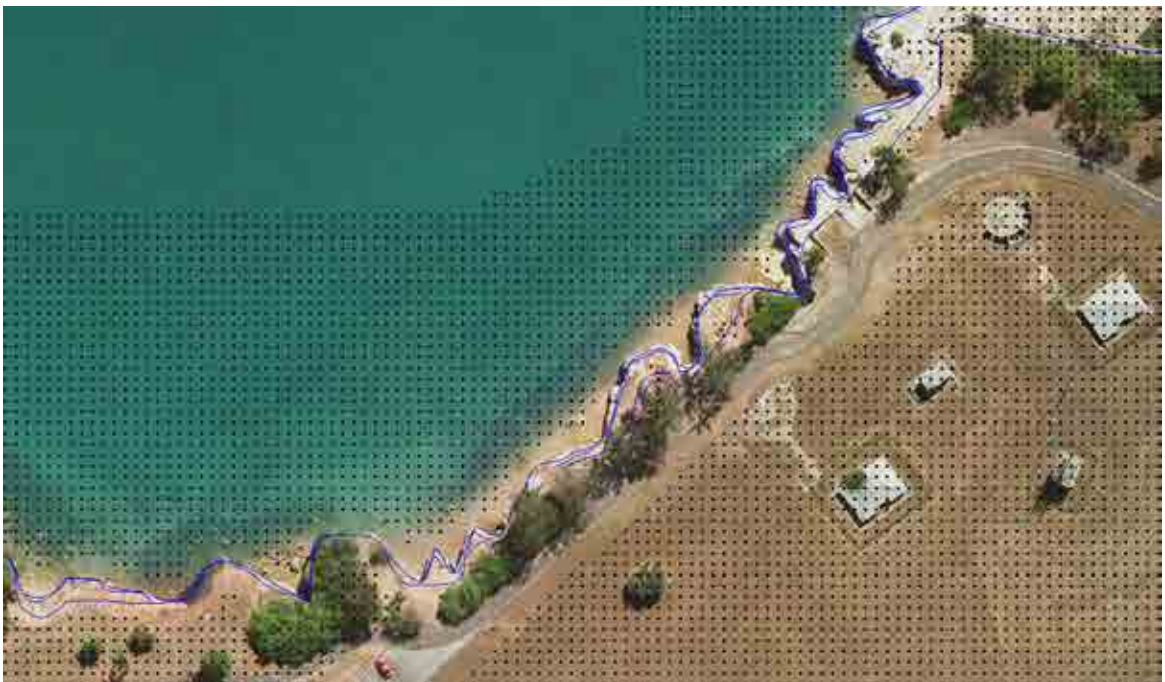
Figure 2-19 2011 Photography of East Point Military Area with Grid and Breaklines

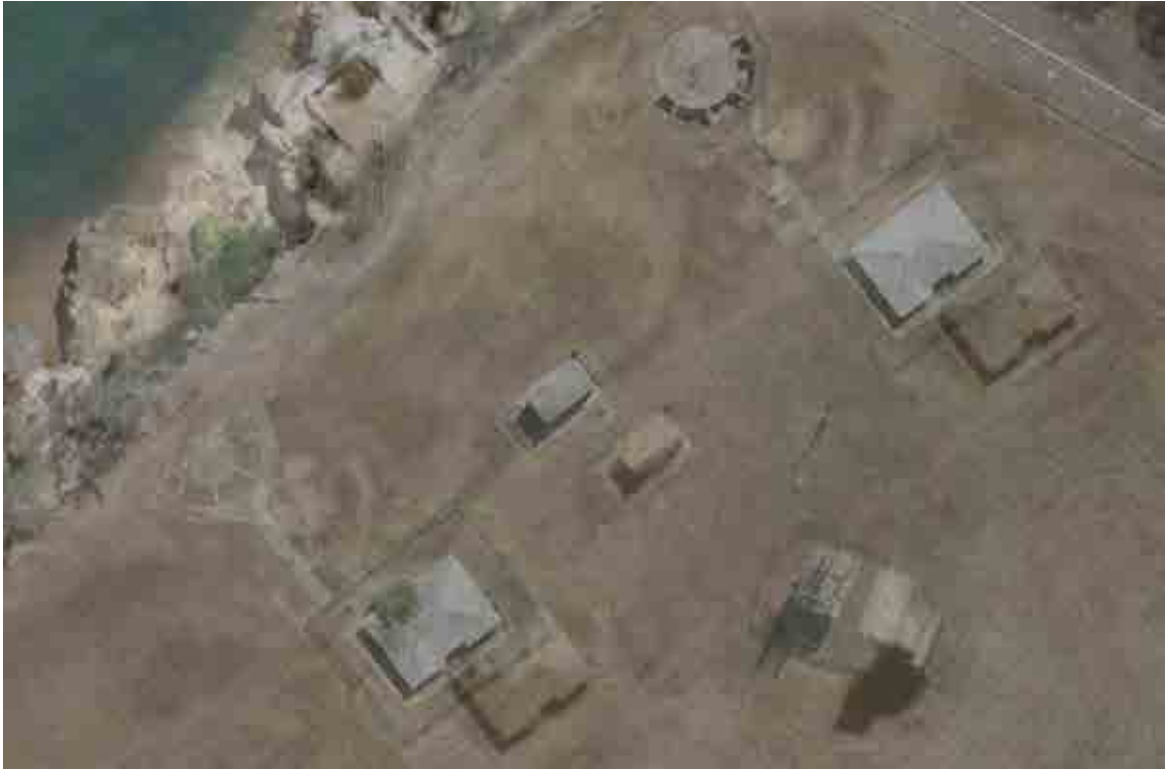
Figure 2-20 Figure Showing Geo-referencing Difference between 1974 and 2011

It is understood that the photogrammetry is carried out automatically on a regular grid which is geo-similar for each date i.e. the point inspected elevations will be at the same geographical point for each photo. However, the photogrammetry we received for all dates had the points for about 15m each side of the cliff line deleted and replaced by break lines as shown in Figure 2-19. This may have been reasonable except that the break lines were not carefully located to pick up the cliff line. Also upon close inspection of a critical area at East Point adjacent to the historical military site, where cliff erosion is threatening these artefacts, the geo-referencing of the historical date was inaccurate as shown in Figure 2-20.

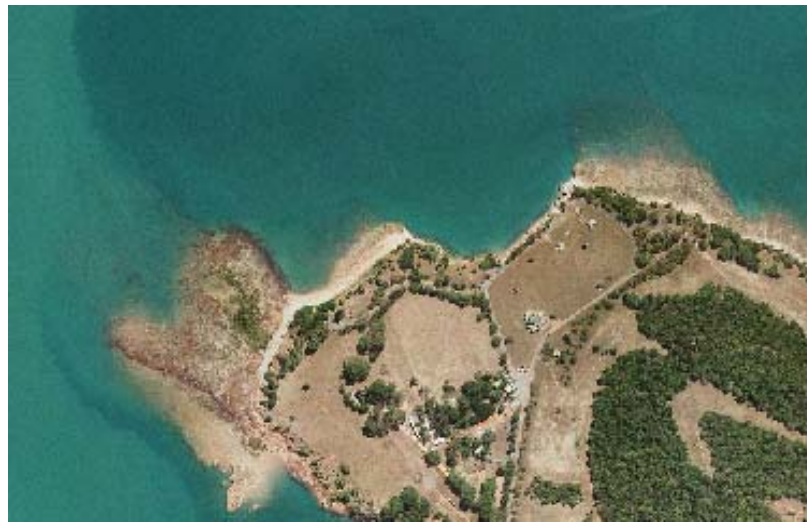
Figure 2-31 East Point showing Lack of Offshore Platform at Military Area

The shore platform is exposed to ambient processes of tides and waves. In the critical areas of East Point and Nightcliff the absence of sloping offshore platform increases wave exposure (refer Figure 2-31).

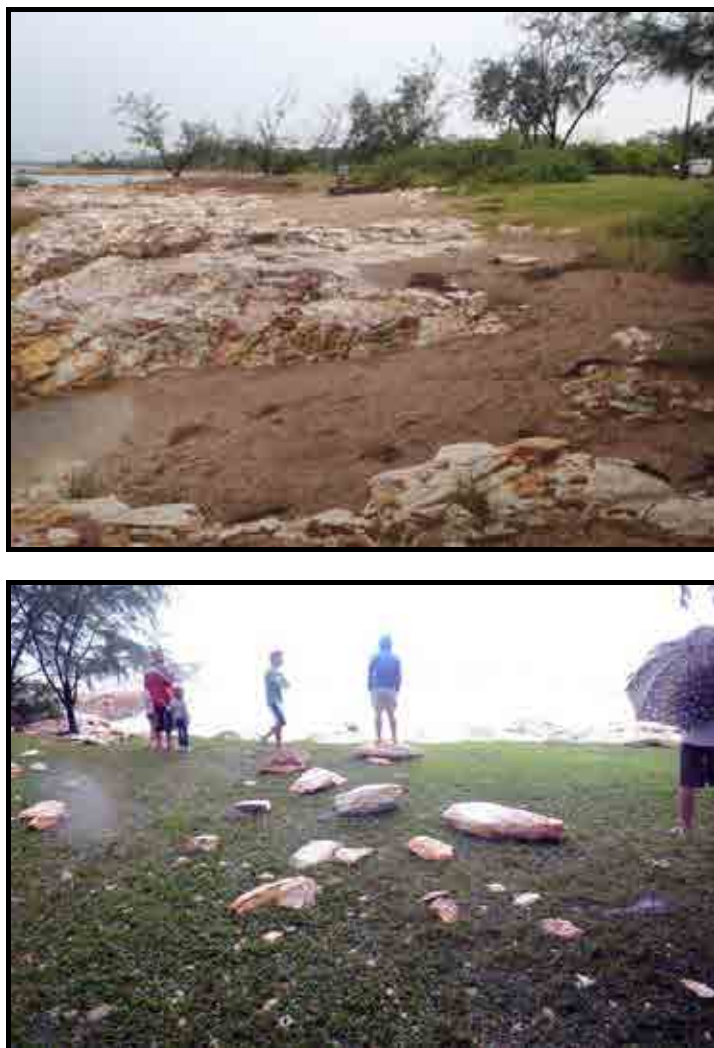
Figure 2-32 Overwash Deposits Near Nightcliff Jetty
(a) Sand; (b) Wave Cast Rock Fragments

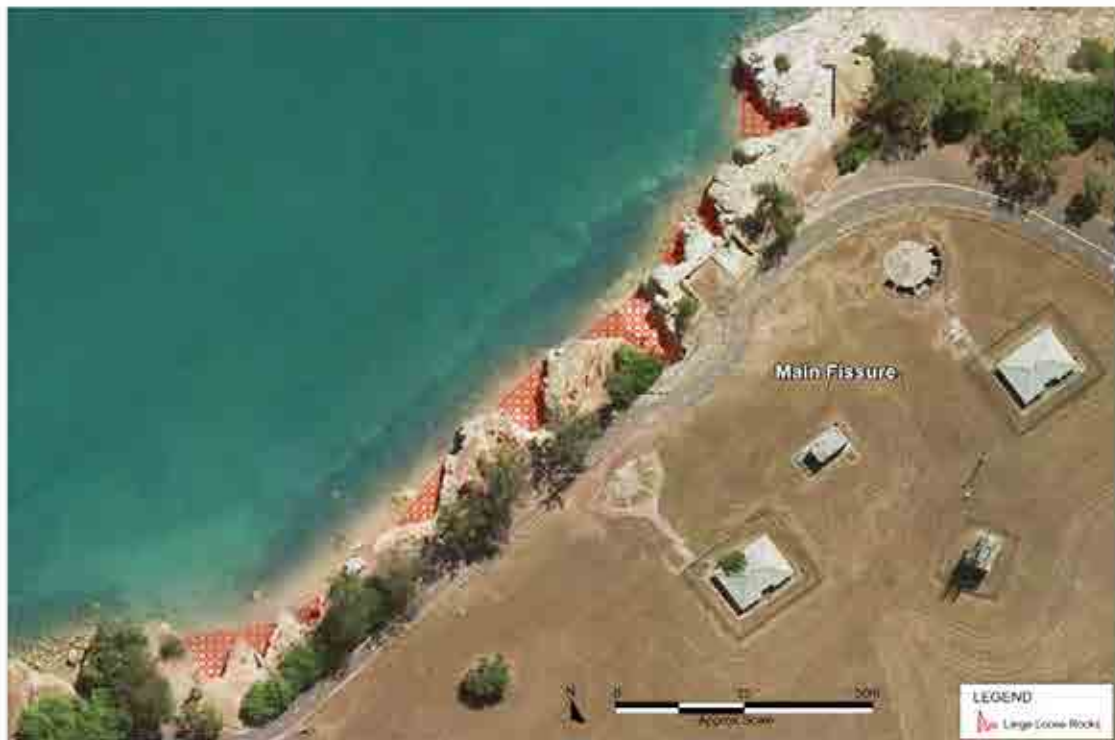
Figure 4-5 East Point North 2011 Showing Possible Areas of Loose Rock Placement

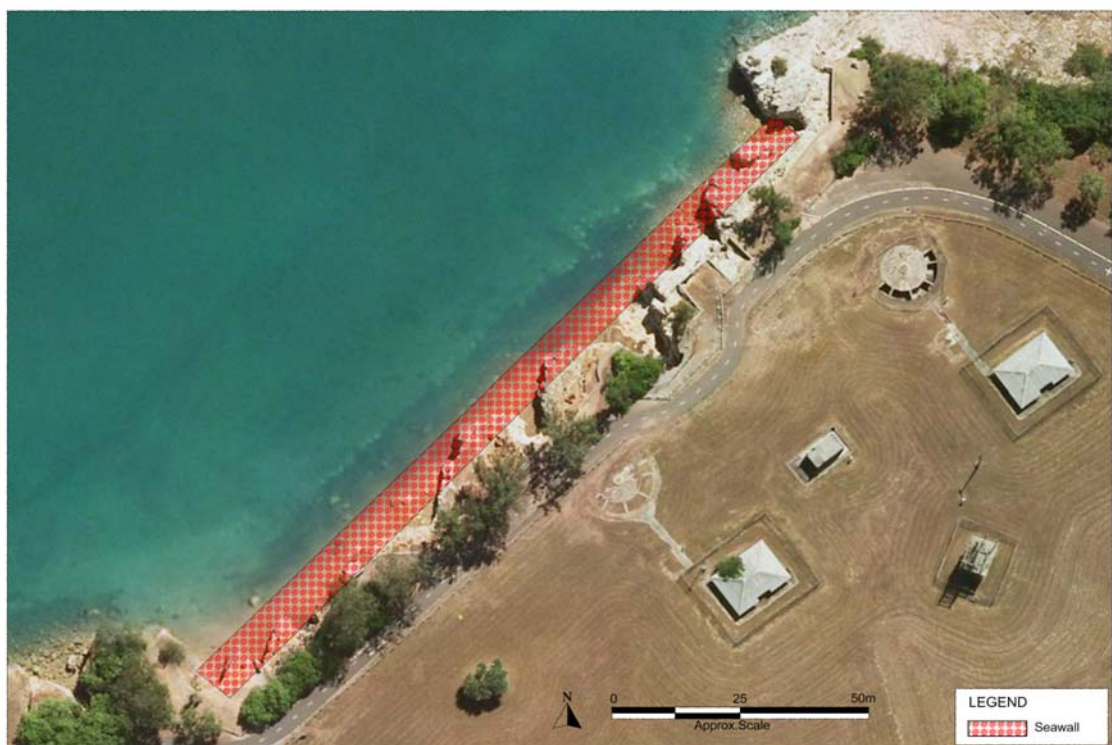
Figure 4-6 East Point North 2011 Showing Possible Seawall

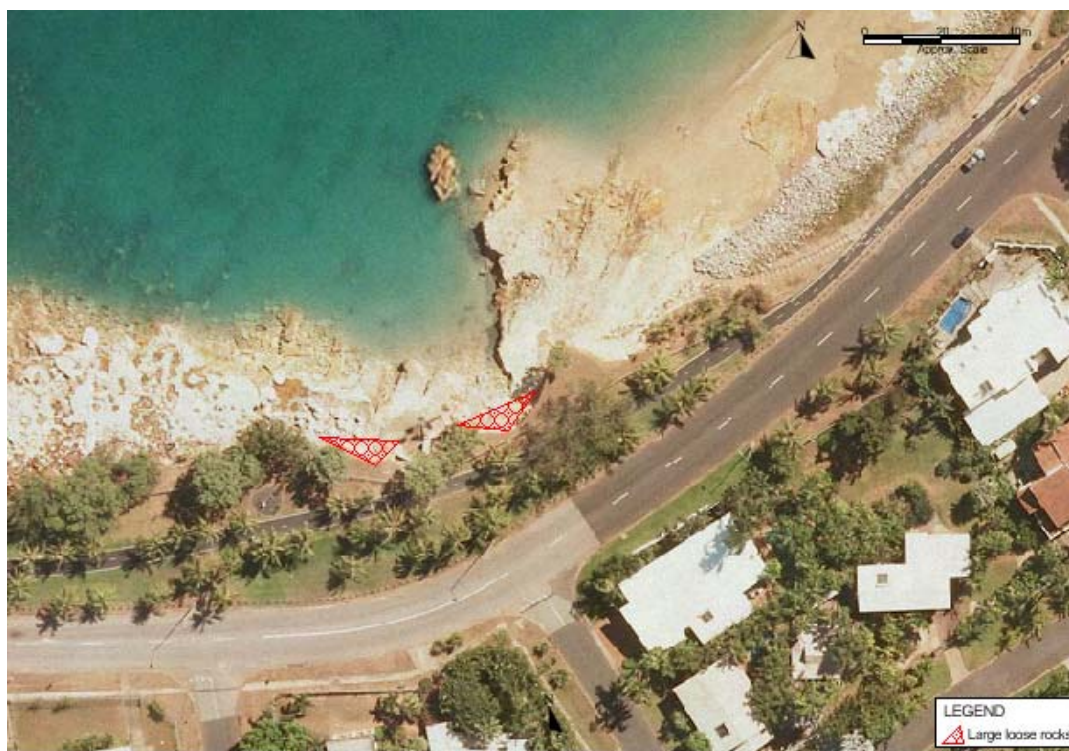
Figure 4-8 Possible Loose Rock Protection at Nightcliff Central

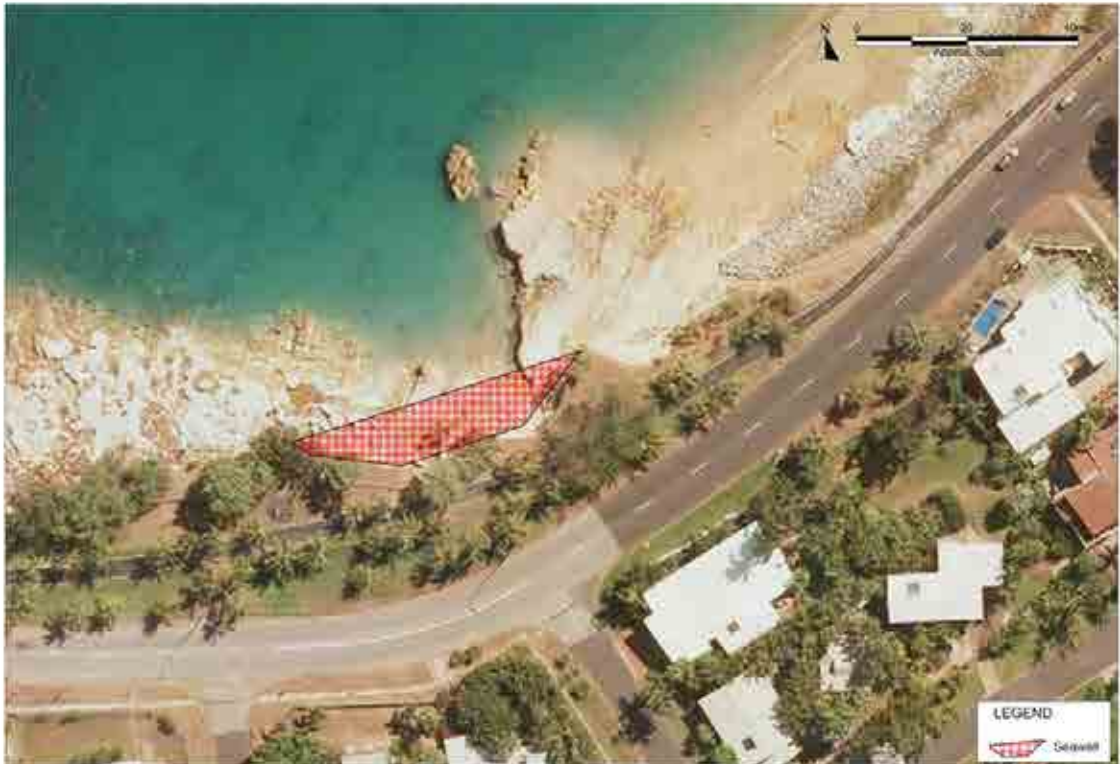
Figure 4-9 Possible Seawall at Nightcliff Central

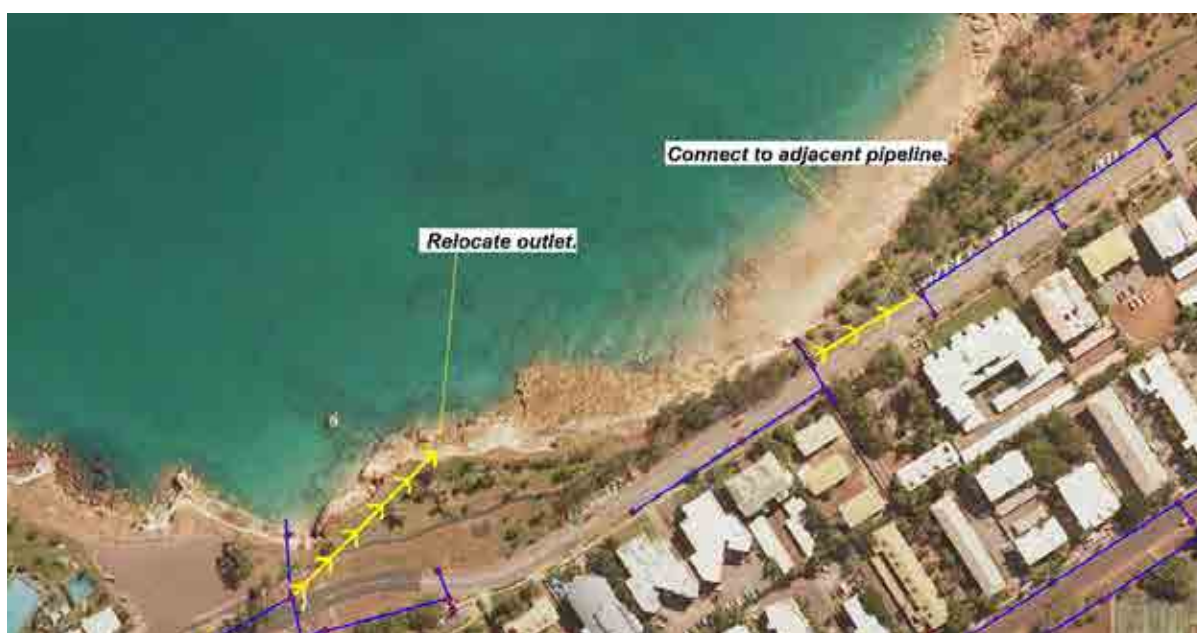
Figure 4-11 Possible Stormwater Drainage Changes at Nightcliff North

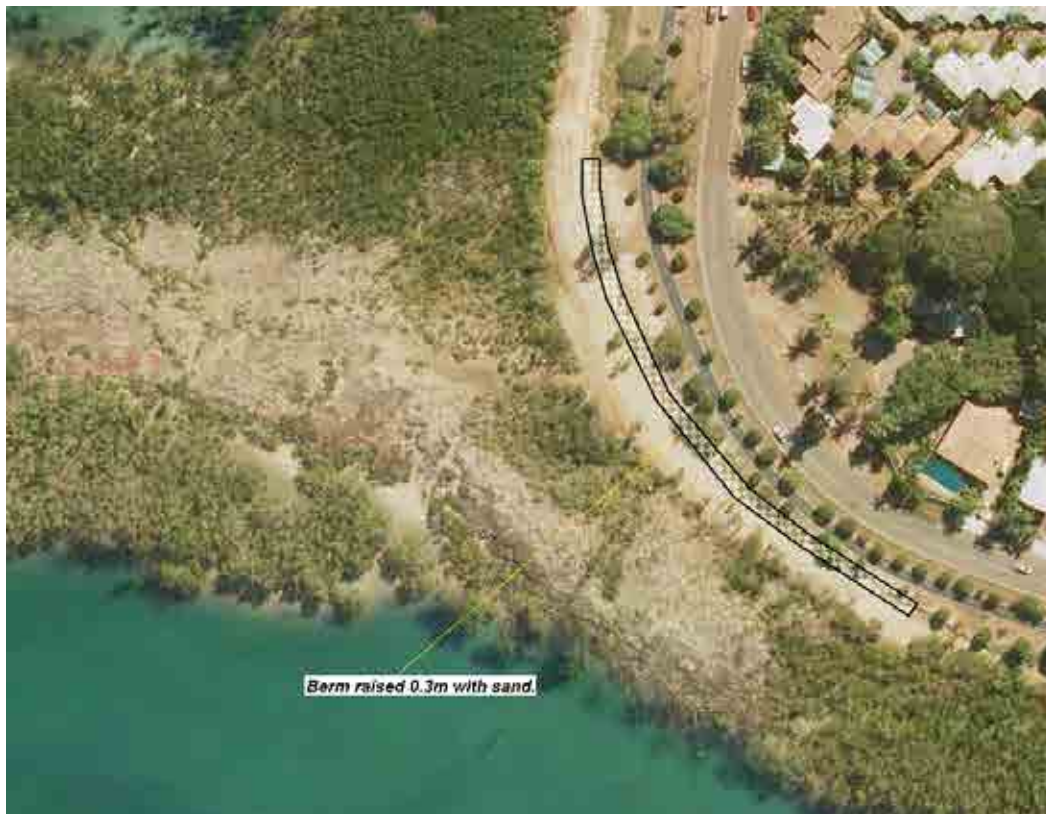
Figure 4-15 Area of Berm to be raised at Nightcliff South

In the longer term, if predicted sea level rise is realised then the management option will need to be changed as the space available to berm raising by sand is limited due to the natural repose angle of sand (about 1:5). When sea level rise exceeds 0.3m (predicted in 50 years) then the option for path protection will need to change to a steeper option i.e. rock. It should be noted that inundation of adjacent properties will also become an important issue at this time.

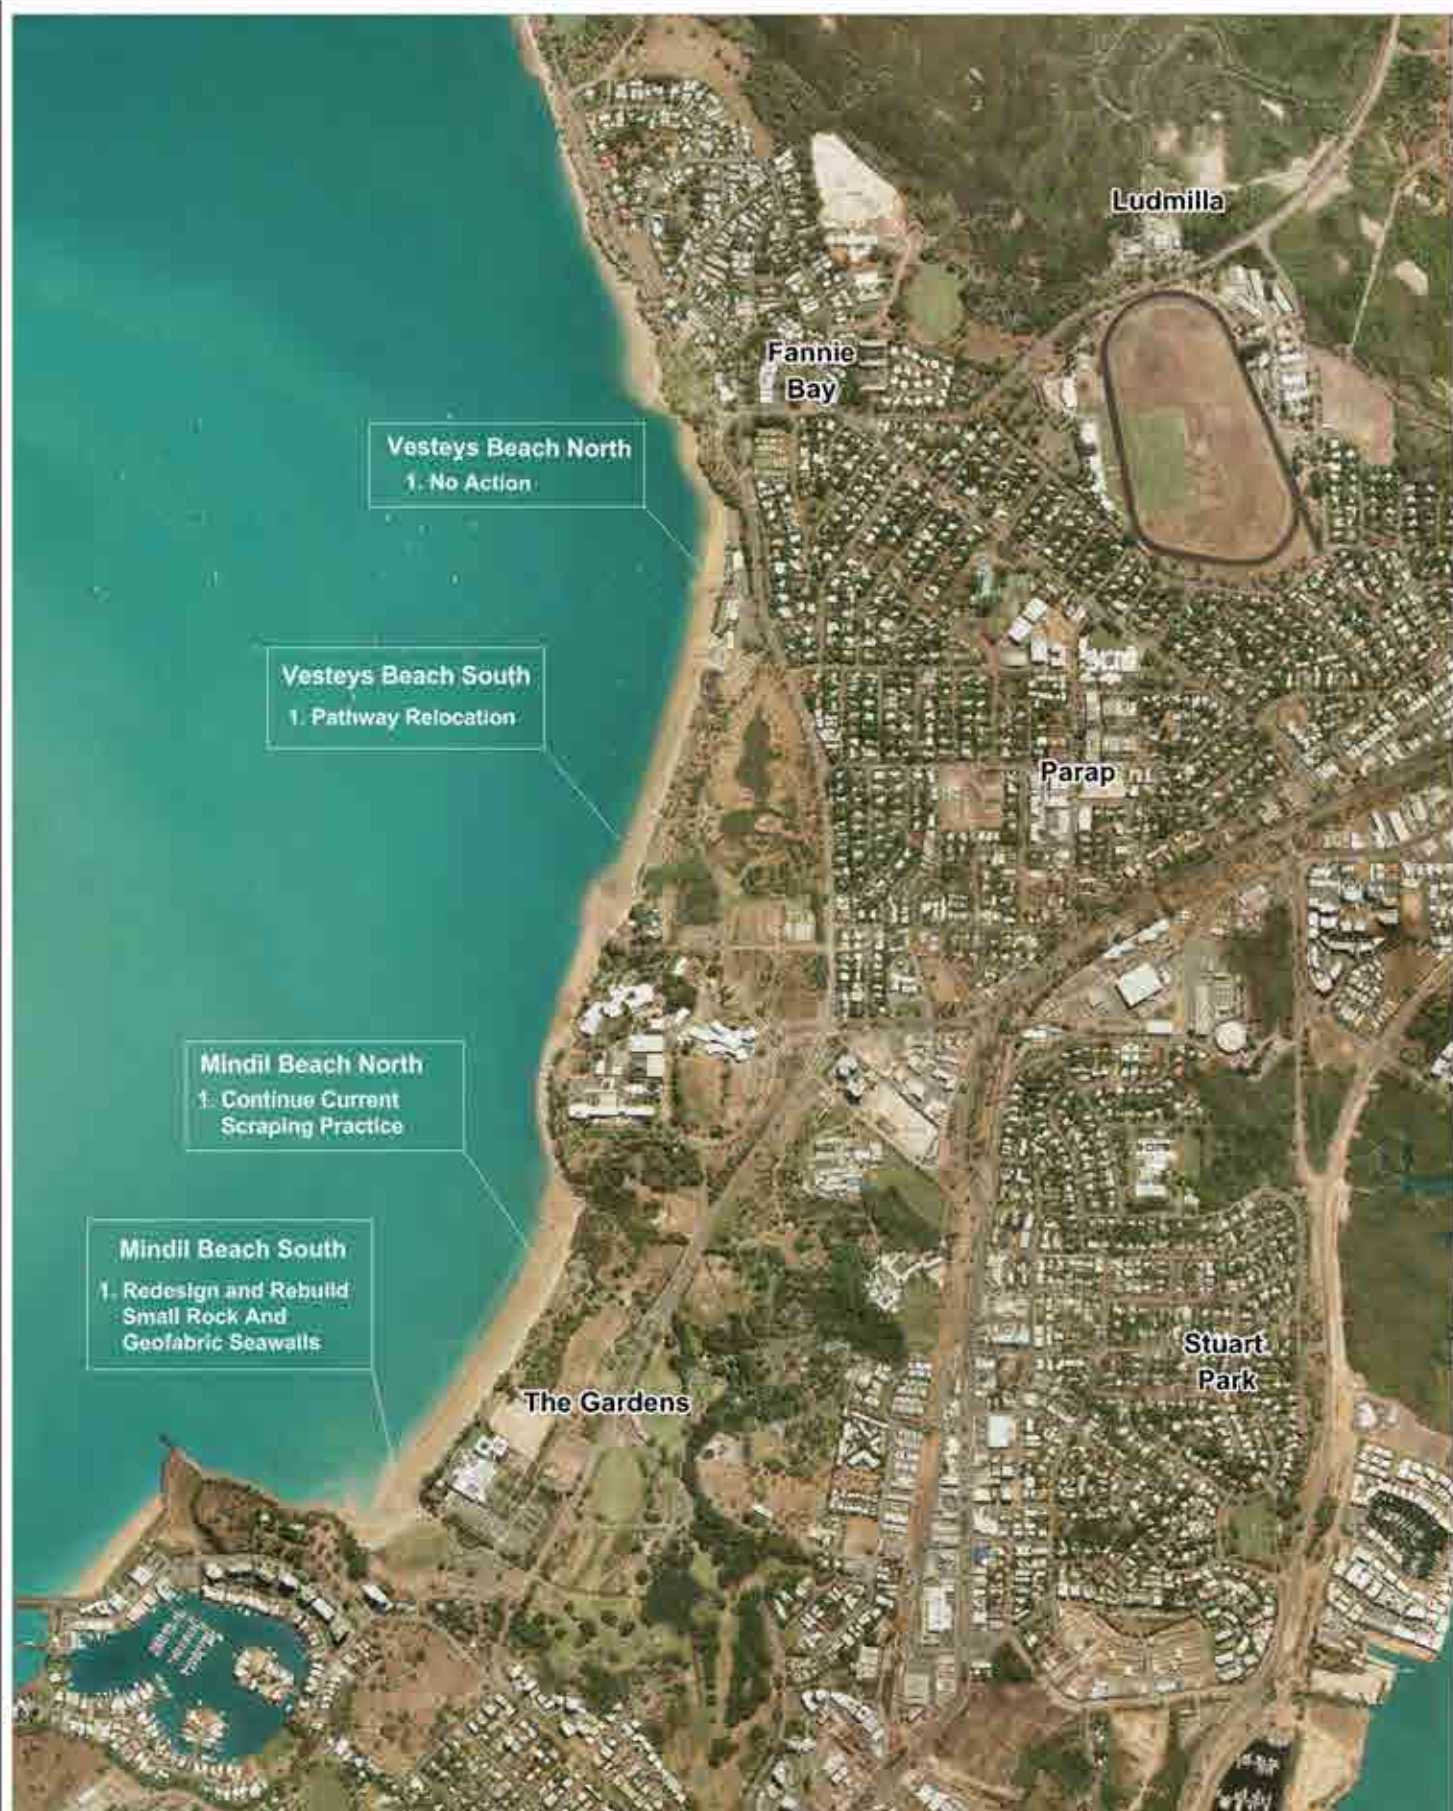
Title:
Mindil and Vesteys Beaches - Recommended Actions

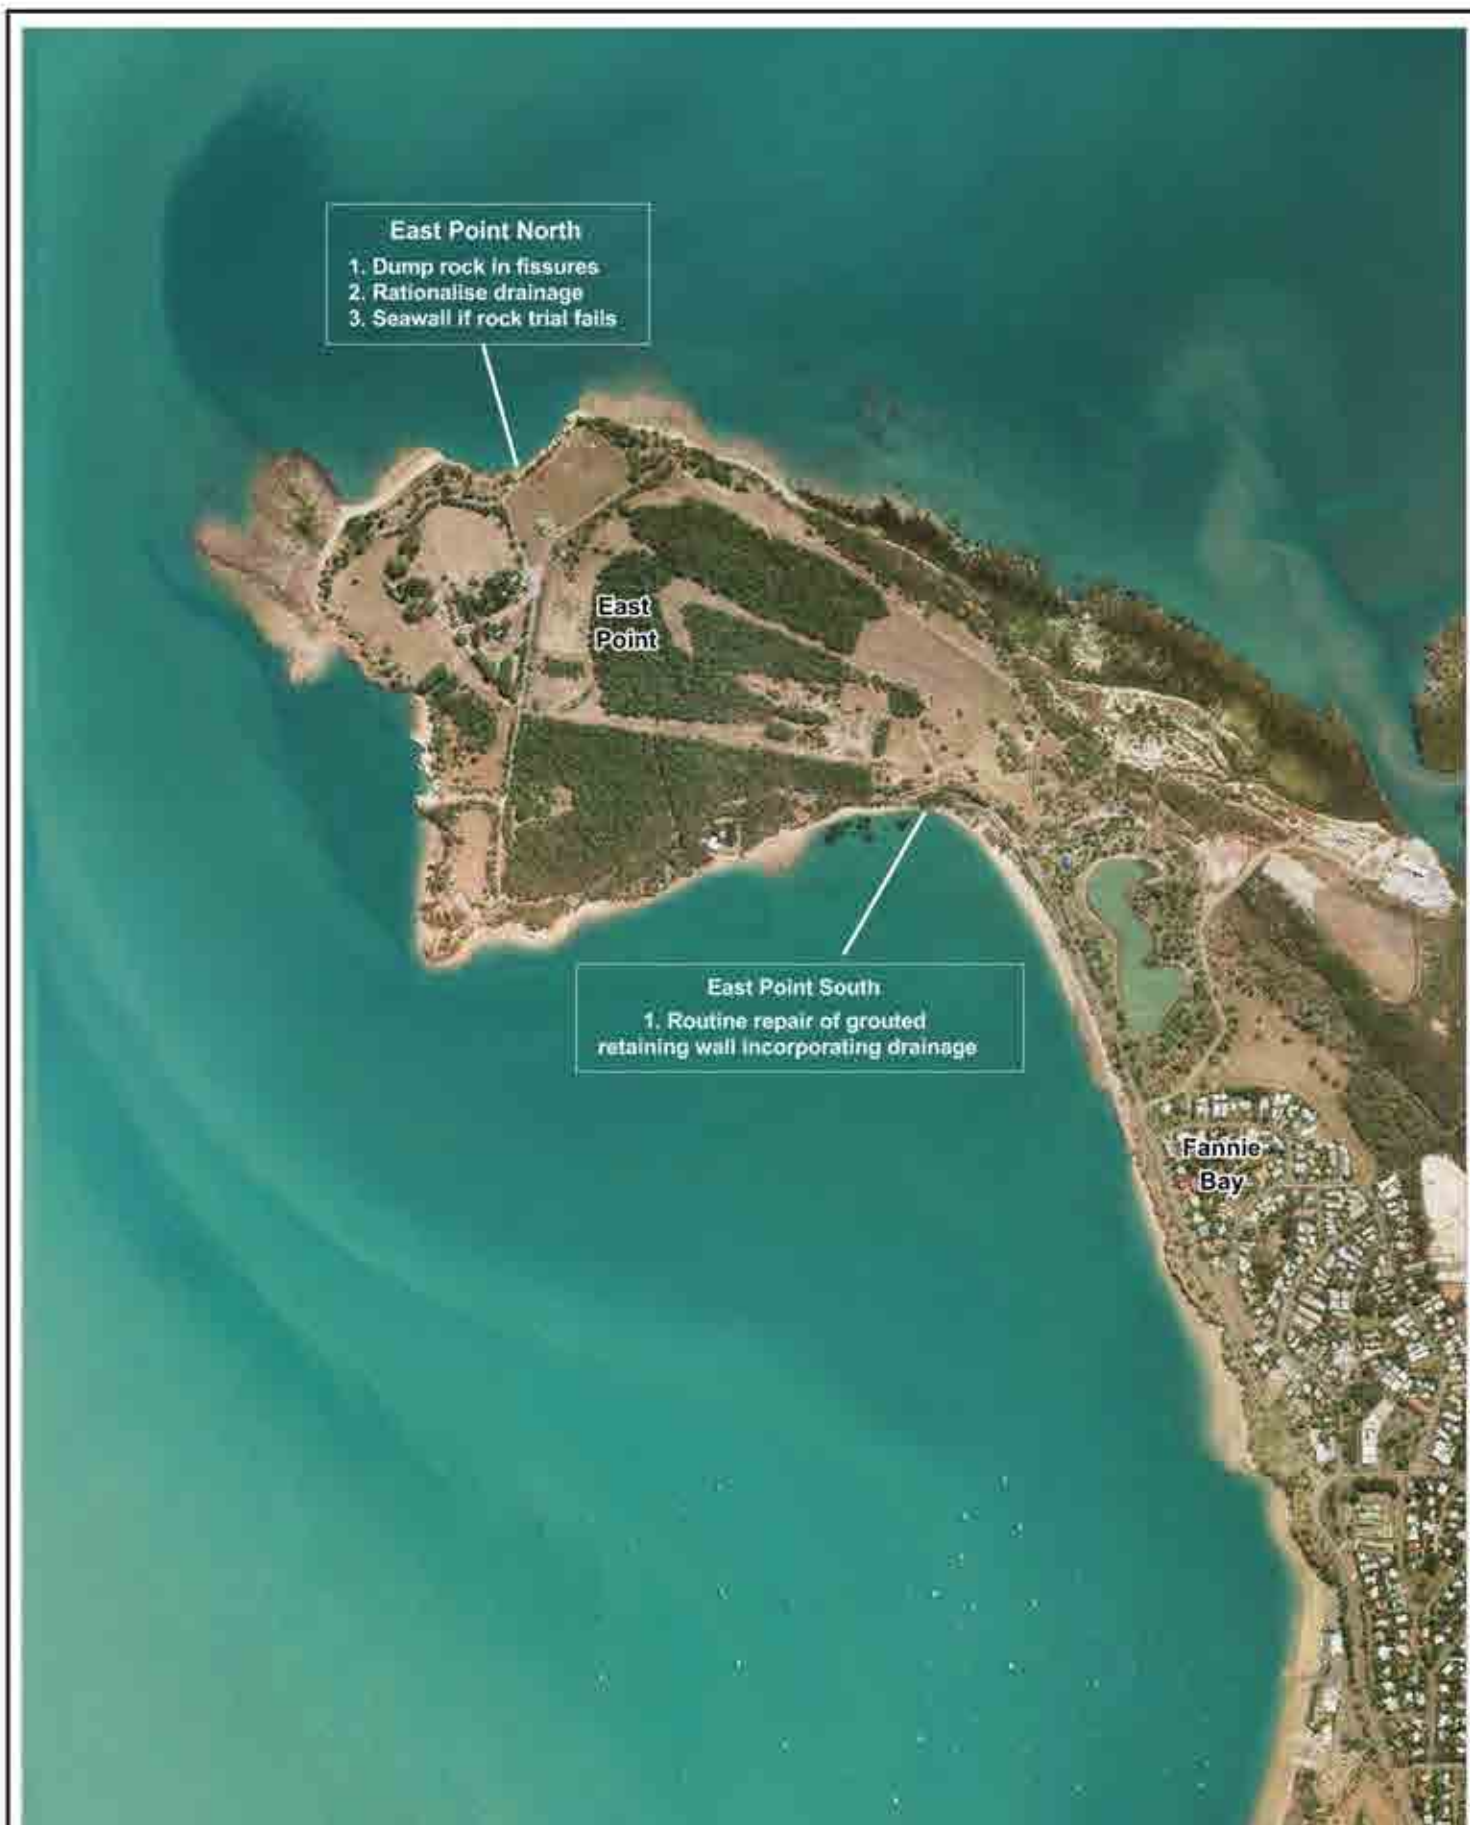
Title:
East Point - Recommended Actions

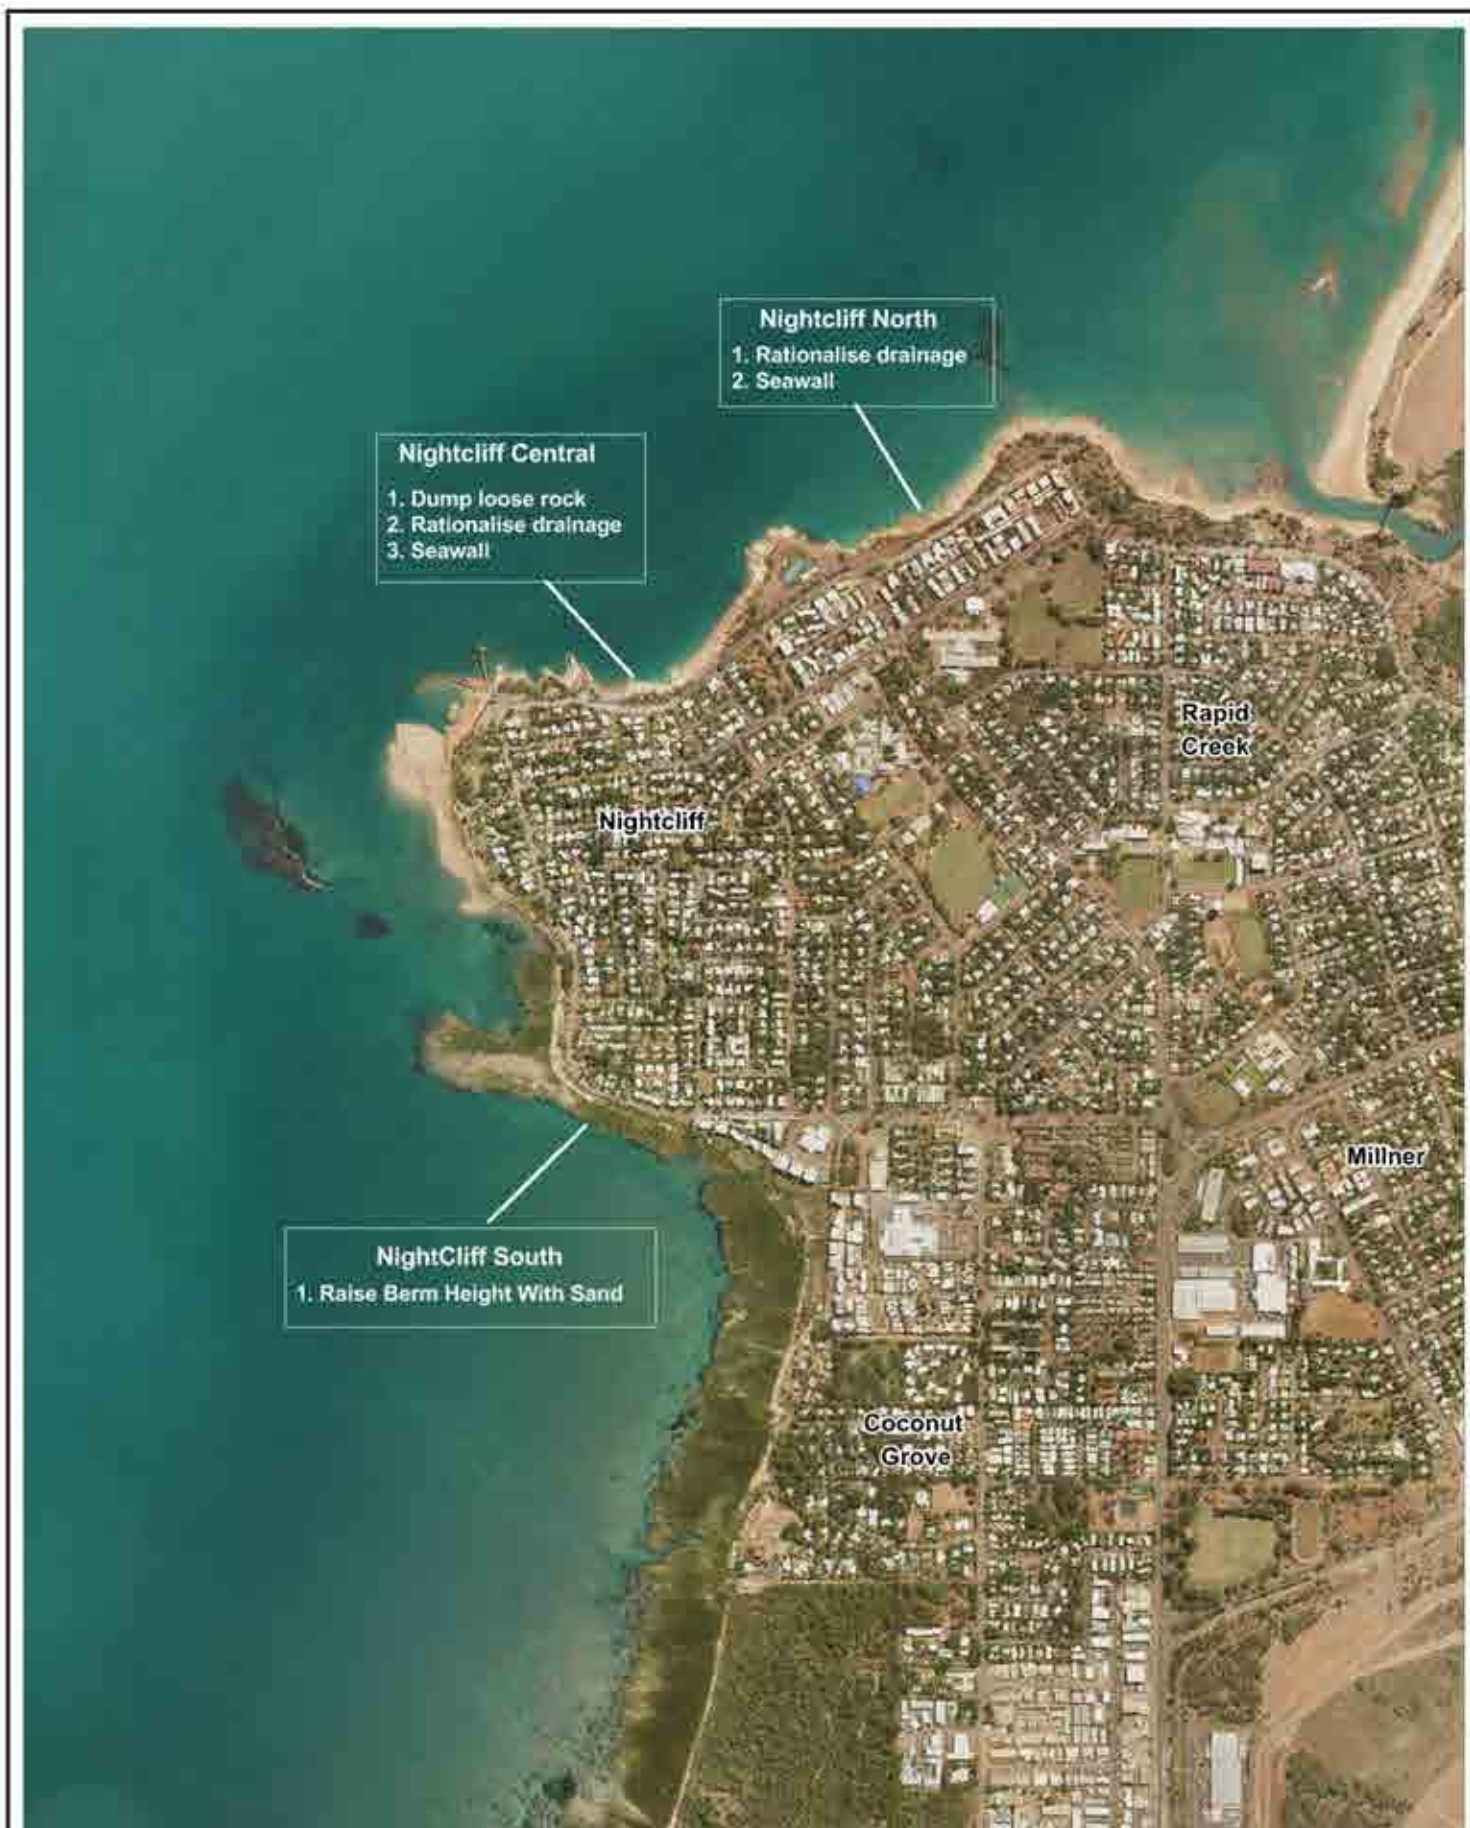
Title:
NightCliff - Recommended Actions

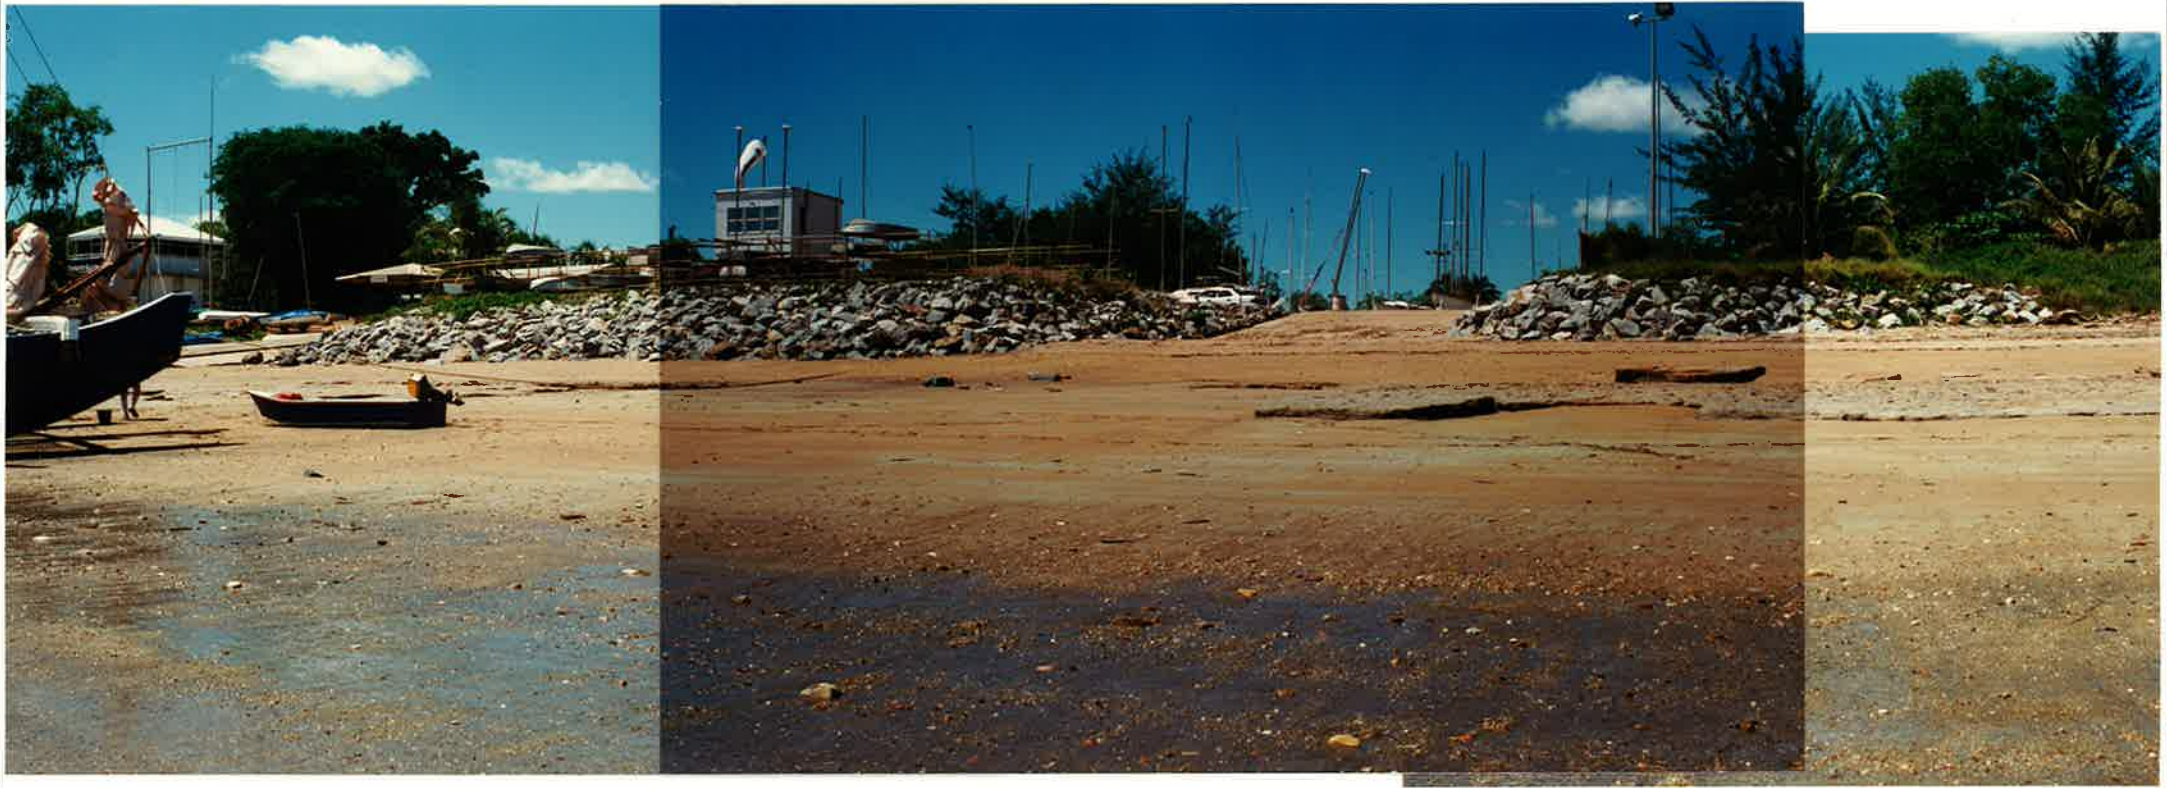
Vesteys Beach Yacht Club, boat ramp with revetment walls
