**Australian Government**  
**Department of Infrastructure,  
Regional Development and Cities**

# **INVESTIGATION INTO ALLEGATIONS OF WASTE MISMANAGEMENT PRACTICES BY AIRSERVICES AUSTRALIA AT DARWIN INTERNATIONAL AIRPORT**

**FEBRUARY 2019**

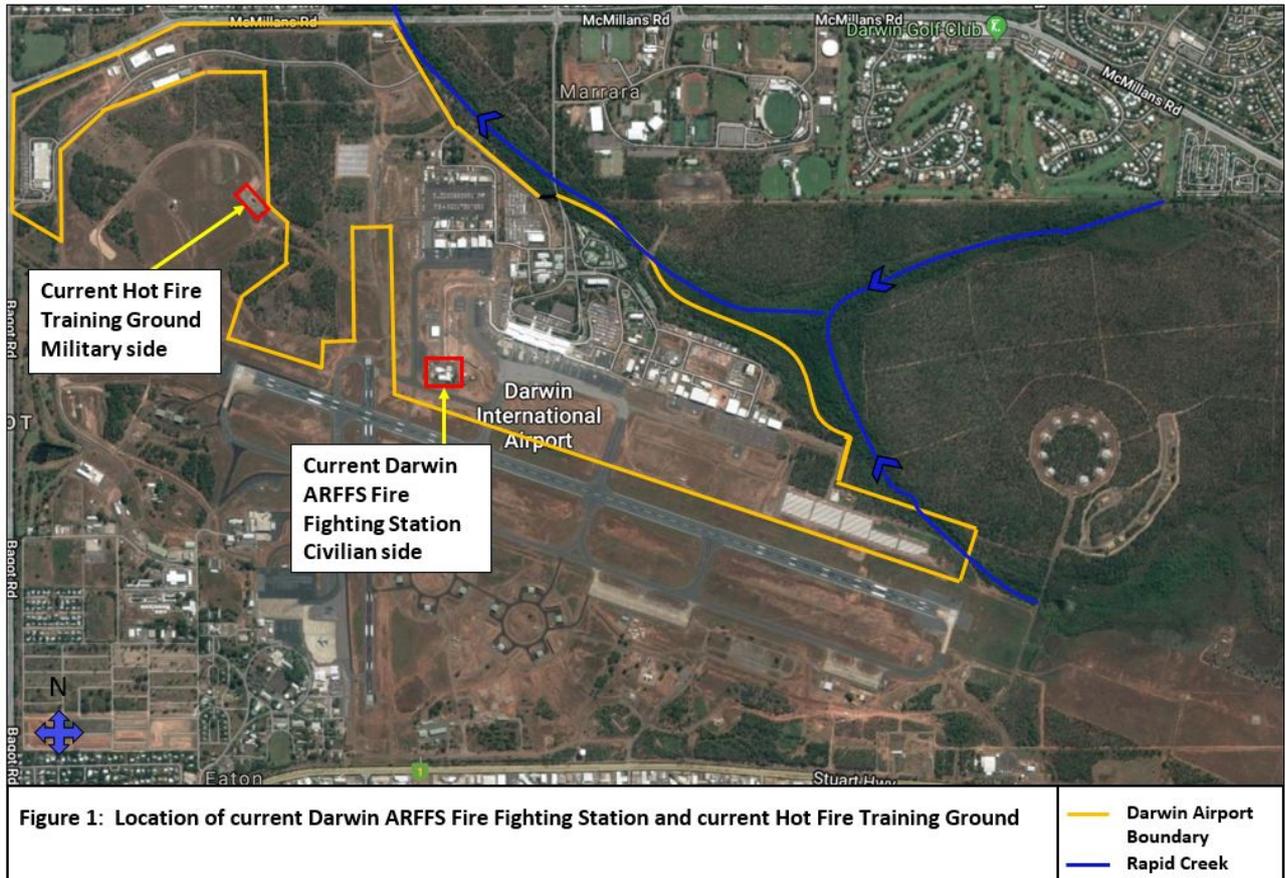
Darwin International Airport is located approximately 8km North East of the Darwin central business district. It is surrounded by the Stuart Highway, Bagot Road, McMillians Road and Amy Johnson Avenue (refer **Figure 1** below). The eastern and north eastern boundary of the site runs parallel to Rapid Creek. Approximately three quarters of the airport's surface water drains into Rapid Creek via sheet flow as well as storm water drains. The north western corner of the site drains into the Ludmilla Creek catchment.

The eight core allegations relate to incidents alleged to have occurred whilst the complainant was employed with Airservices' Darwin ARFFS at four locations on Darwin Airport: the ARFFS fire station, the station training ground and Rescue Road on the civil side and the Hot Fire Training Ground (also referred to as the Large Mock Up [LMU] area) on the military side of the airport.

The Darwin ARFFS Station is located on the civil side of the airport (refer **Figures 1 and 2**) and is located South West of the DIA terminal. The site comprises of:

The Hot Fire Training Ground (HFTG) is the current Darwin firefighting station training ground located on the military side of the airport (**Figure 1**). The training ground is also referred to by two other names: 'the current fire training ground' in the Defence PFAS investigation reports and the 'Large Mock Up (LMU) area' as referenced by current Airservices' employees and the complainant. For consistency, this investigation will reference this training ground as the HFTG.

The Hot Fire Training Ground (HFTG) is located on the military side of the airport and is administered by Defence (**Figures 1 and 3**). Regulation 4.01 of the AEPR does not apply to undertakings on the military side of the airport.

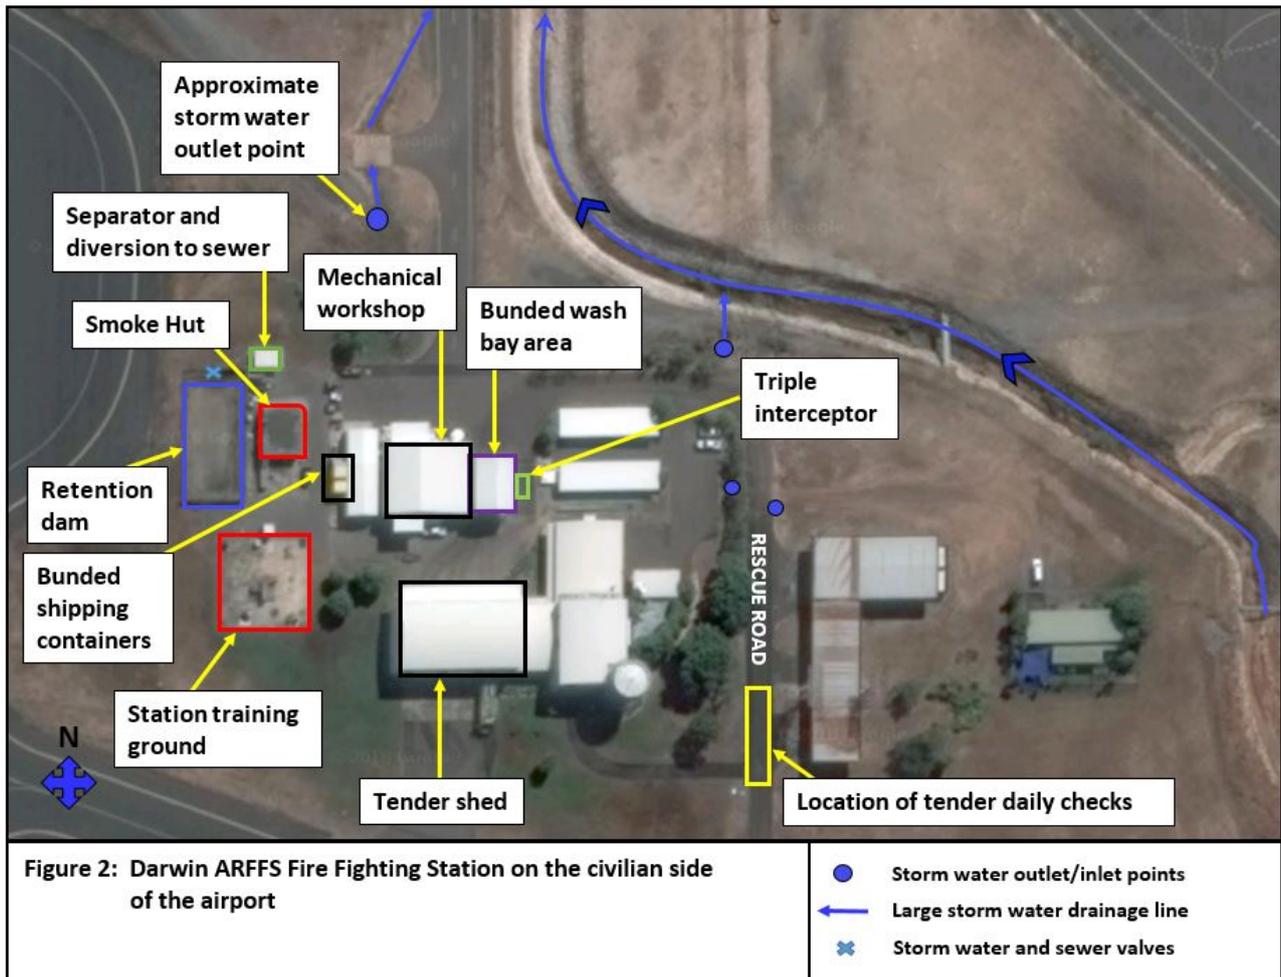
- a bunded wash bay;
- a smoke hut;
- a training ground;
- a retention dam;
- the main station;
- a maintenance area;
- three bunded shipping containers;
- a main shed for the tenders (fire trucks);
- an undercover two phase separator; and
- a triple interceptor.

The locations of the buildings mentioned above are shown in **Figure 2**. The aerial photograph below differs from the site inspection photographs in the Appendices in one aspect - since this aerial photograph was taken Airservices has installed three additional bunded shipping containers.

The allegation refers to the daily testing of the fire tenders' water discharge systems which are activated to confirm that they are operational at commencement of the morning shift. The vehicles are parked at the Southern end of Rescue Road when this check is undertaken (**Figure 2**).

In the North West corner of the site is a storm water outlet point (that receives water from the retention pond) and is an open unlined drain. It can be seen in **Figure 2** that the water continues parallel to the large storm water drain and road. The drainage line then continues North until hitting the tarmac and turns east to travel under the road and enter the main storm water drainage line.

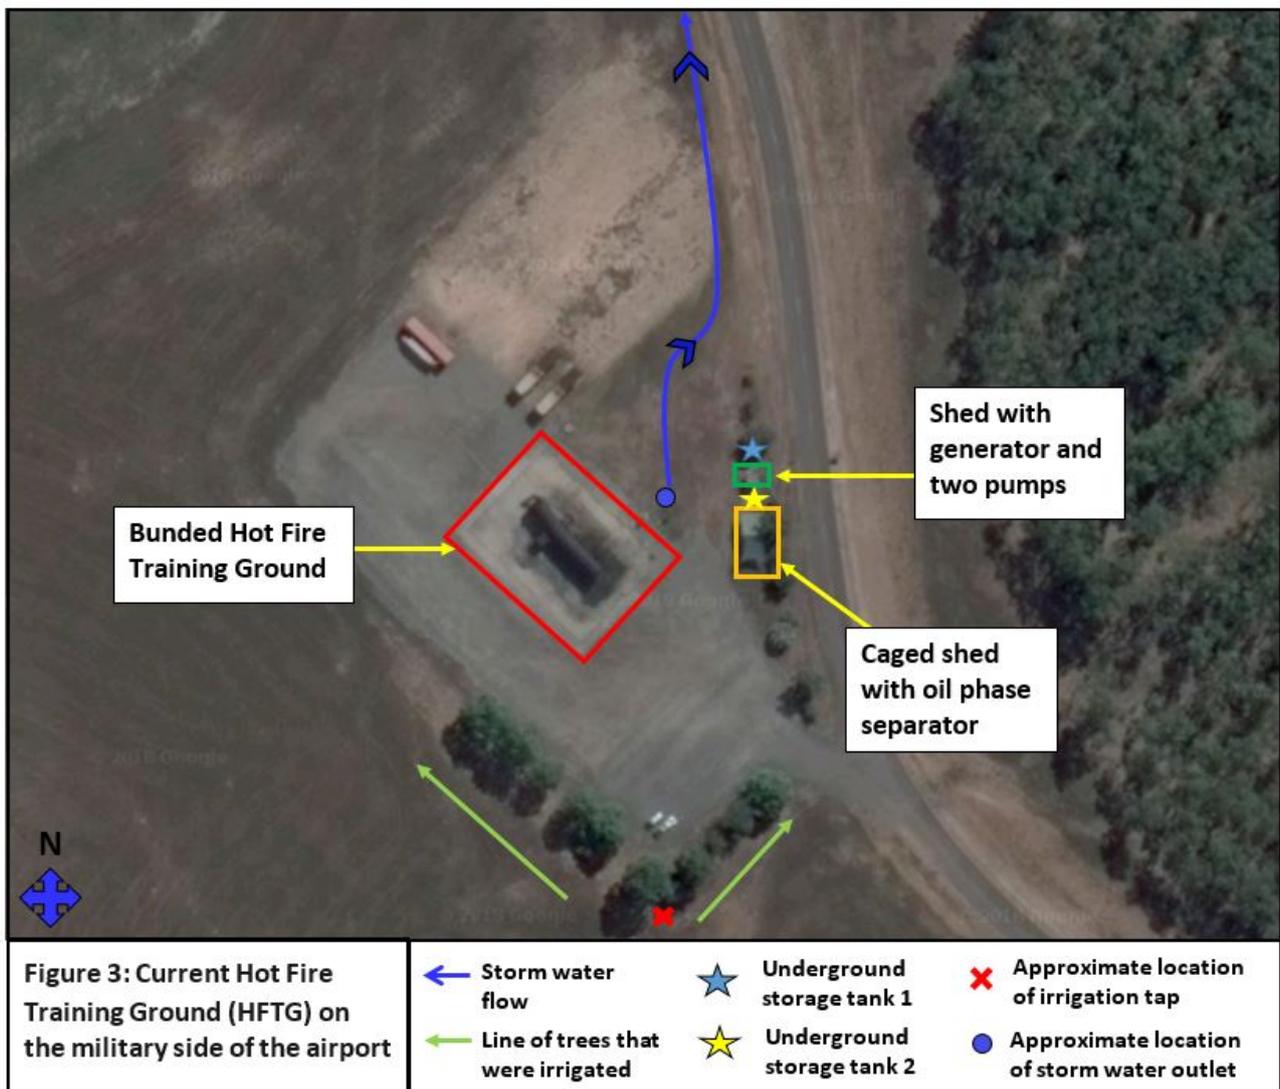
- a large training pad with a mock fire training aircraft constructed in the center of the pad.
  - The training pad is bunded and has a large drain located on the North East corner of the pad (**Figure 3**);

- the HFTG has two underground storage tanks:
  - one is located north of the small shed (**Figure 3**);
  - the second is located between the two sheds (**Figure 3**);

- two sheds:
  - the Northern shed houses the generator and a pump (**Figure 3**);
  - the second shed (the Southern shed) houses the oil phase separator (**Figure 3**);

- to the South of the HFTG site are two lines of trees bordering the graveled area and a decommissioned irrigation tap and stand;
- the trees and irrigation tap (marked by a red X in **Figure 3**) are discussed in Allegation 1.

As mentioned above, the training pad has two valves, the first valve discharges water from the training pad directly to storm water via the drainage channel located on the North East corner of the pad. The water travels along the open unlined drainage line in a Northerly direction before turning in an Easterly direction to enter the civil side of the airport via a concrete drain that traverses under an airside road. After exiting this drain, the water pools and then flows North through vegetation and along a dirt road. It then enters the Osgood Road open unlined drains where it travels East to eventually enter Rapid Creek.
