Cane Toads of East Point Reserve Project Report

Compiled by Project Officer Daisy Lippiatt

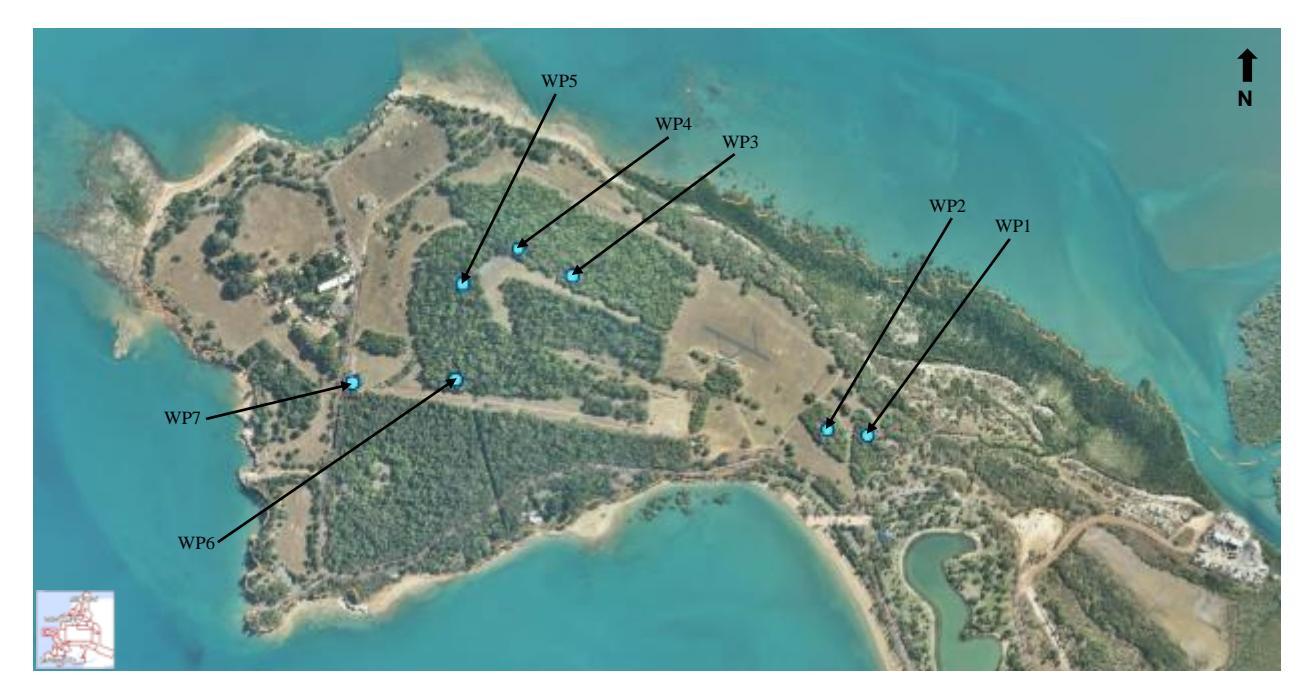
Figure 2 indicating location of each wallaby water point and its WP number allocation.

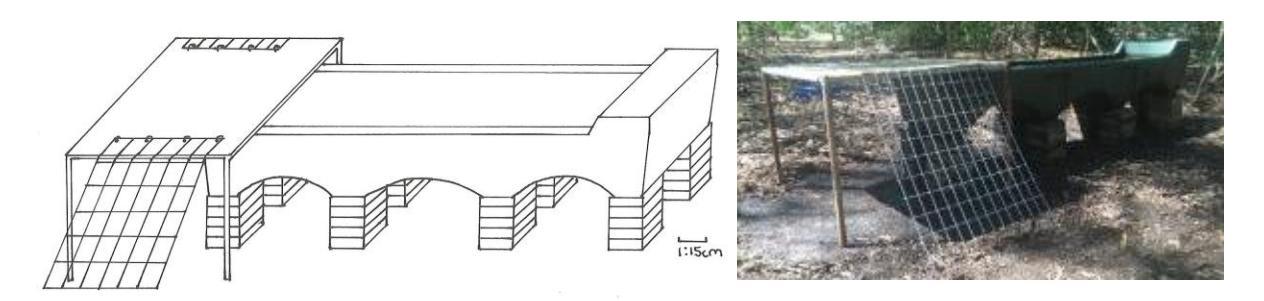
WP 2 was modified by increasing the height of water access to 69cm. Forty (40) bricks in total were used to raise the water trough, a metal reinforced table was placed on one end of the raised water trough with two wire ladders, one secured at an angle of 30°, the other at 45°. A Poly Riser and elbow were fitted to enable auto filling of trough. This design ensured accessibility for juvenile wallabies, small mammals or reptiles to the WP. See figure 3 for scaled diagram of the design. This WP was then surveyed using two infrared digital scanning cameras capturing 3 images every 2 minutes for 3 consecutive days.

Figure 3 left shows scaled diagram of WP modification design, right image of design built at WP 2.

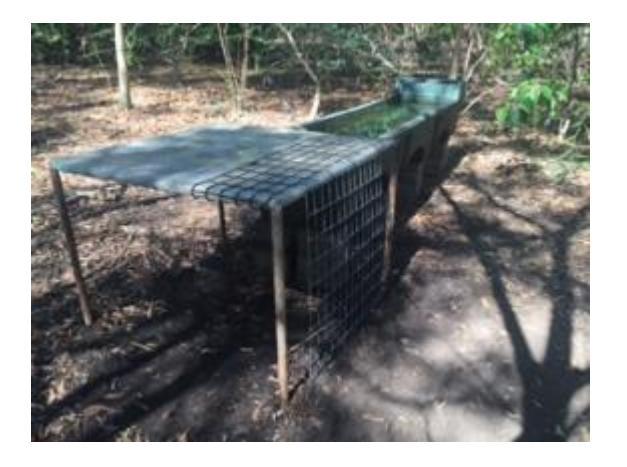
This design was further modified by placing one wire ladder over the table to sit directly in line with the two table legs and securing the other wire ladder onto the table top as shown in Figure 4 to allow possums to climb onto the table to access water. This WP was then surveyed using the same camera settings as previous survey for 4 consecutive days. Cane Toads of East Point Project Report Daisy Lippiatt

Figure 4 is an image of altered design concept, and is currently still in place at WP 2.

The initial WP modification design still enabled cane toads to enter the WP. Readjustment of the angled wire ladders to sit at a 90 ° angle on one side of the table in the second trial excluded cane toads from the WP. Camera footage shown in Figure 15 revealed both large and small wallabies drinking from the modified WP. Possums were seen to regularly use the table to access water, although possums climbed up the table legs instead of using the ladder. Possums were also seen accessing the water from climbing up the trough itself. No reptiles were observed attempting to access any WP. Initial footage showed a decline in wallaby usage of the WP after modification, although after seven days of surveillance, wallabies were frequenting the water source regularly.

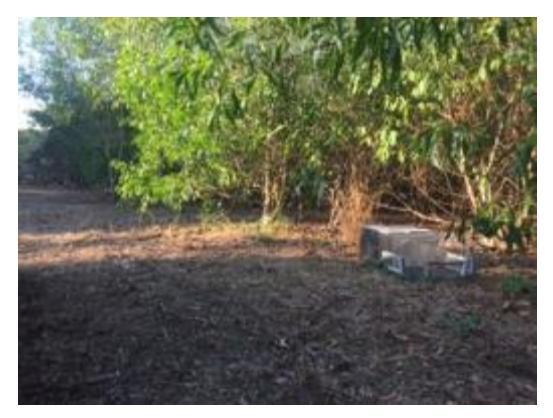
Two cane toad UV lights and 12V solar panelled traps were repaired and borrowed from Mr Sawyer and set up on 10 July 2015 with approximately 2L of water available inside. One trap was placed near cane toad accessible WP4 and one near the empty WP1 without an accessible water source for over 500m, as shown in Figure 5. Traps were checked daily for two evenings.

Figure 5 shows cane toad trap position in relation to canopy cover and position.

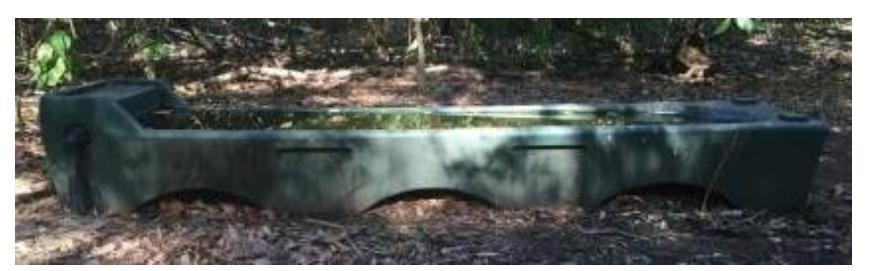
Water Point 1, 2, 3 and 5 are Rapid Plas Pty Sweep Troughs. All poly extra heavy duty water trough, 250cm L x 55cm W x 47cm H, 140 Litres capacity, 1" float valve - fully protected, double walled trough shown in Figure 6. WP 1, 2, 3 and 5 are in good condition and can be easily modified.

Figure 6 shows the Rapid Plas Sweep water trough in place at WP 1, 2, 3 and 5 in East Point reserve.

All WP should be raised at least 60cm above ground level to prohibit cane toad access to water troughs. A wire ladder will need to be attached, folding over the top of the trough to allow possum and possible reptile access to WP. See Figure 22 for design. Time limitations did not allow this design to be tested and is recommended that further camera

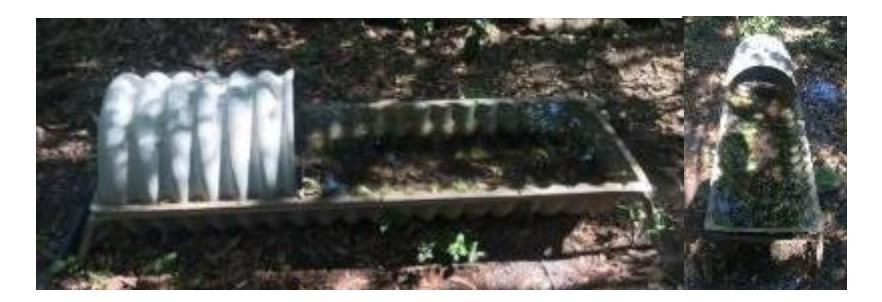
Wallaby Water Point 4 is not be suitable for modification standing approximately 23cm high, as shown in Figure 7.

Figure 7 is an image of WP 4 in East Point reserve, constant moist soil due to leaks in trough. As shown in Figure 8, Wallaby Water Point 6 stands 21cm above ground level. Water point may potentially be able to be modified, further investigation is needed.

Three water points (WP 4, WP 6 and WP 7) may be able to be modified in the same manner without replacing, although costing will include replacement of old WP with Rapid Plas Pty Sweep Troughs.

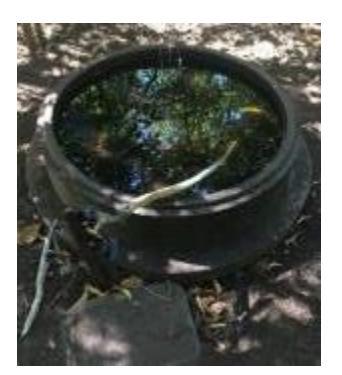
Figure 8 shows the design of WP 6 in East Point reserve.

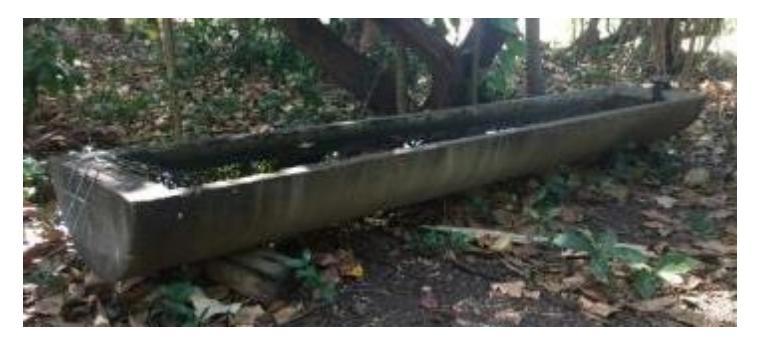
Wallaby Water Point 7 is in good condition and could be easily altered, standing 25cm high, shown in Figure 9.

Figure 9 indicates the design of WP 7 in East Point reserve.

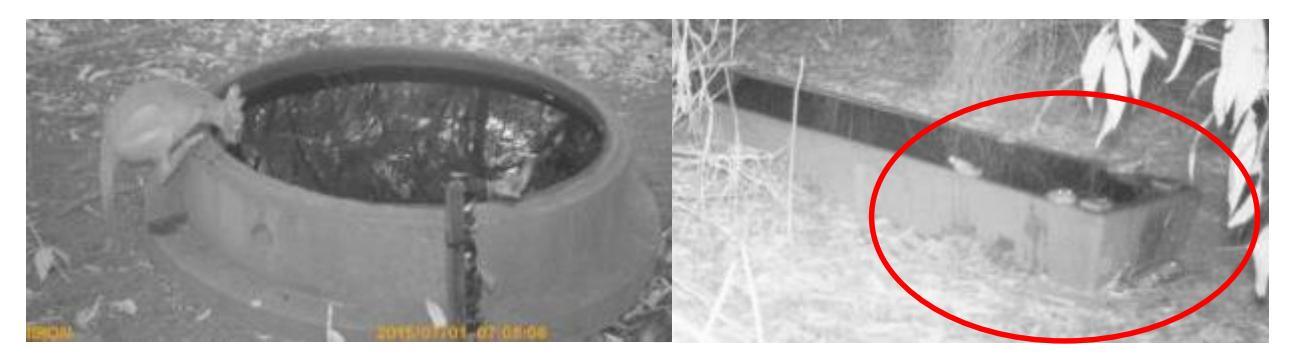
Camera footage shows wallabies, possums and cane toads are utilising all WP within East Point reserve. Only mature Agile Wallabies were drinking water from the troughs. Example footage captured shown in Figure 10.

Figure 10 left shows a female Agile wallaby accessing WP 6, right showing six cane toads utilising WP 2 in East Point reserve.

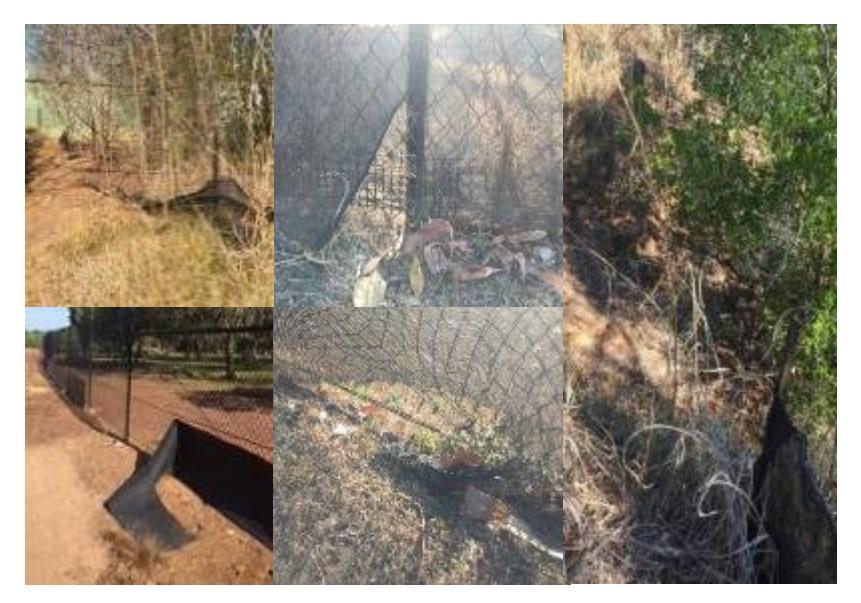
The inner boundary of the fencing between Lake Alexander and East Point Reserve have potential for application of mesh fencing although most of the fencing is raised over one inch from the soil. The north eastern and eastern side of Lake Alexander fencing has inadequately maintained rubber fencing 60cm high and approximately 500m in length with approximately 100m damaged. The fencing on the south eastern and south of Lake Alexander has mesh 60cm high, also inadequately maintained. In areas where mesh is buried approximately 5cm in depth, mesh is still intact. Figure 11 shows why cane toads will be able to evade the fence line.

Figure 11 shows examples of fence damage. Top left is fence line behind Lake Alexander shed, top middle is a damaged reptile entry point, left is drain from Lake Alexander run off in the middle of fence line behind Lake Alexander shed, bottom right example of rubber mesh damage and bottom middle is example mesh damage surrounding Lake Alexander.

There are three small reptile entry points using black wire mesh fencing on the Lake Alexander fence line, all damaged, approximately 20cm in length, 10cm high with 2.5cm cross hatches. The East Point reserve fence line runs for 850m, whilst the Lake Alexander fence line runs for 650m indicated in Figure 12.

- Mesh application for approximately 850m along East Point reserve fence line and 650m length of mesh for repairs and replacement of rubber mesh along Lake Alexander fence line. Mesh to be clipped to existing fences. Installation of three reptile entry points along East Point Reserve fence line.

- Replacement of existing reptile entry points along Lake Alexander fence line as per Cane Toad Proof Your Backyard (2010) design.
- Use of a tractor/grader to strip at the base of the fences above, regrade to deposit the soil on top of the trailing cloth skirt of at least 20cms deep and sitting 60cms above ground level.

- Re-use rubber mesh from Lake Alexander fence line and replace fencing behind sheds in Lake Alexander. Star pickets will be placed every 2m and rubber alternately placed to one side of a picket to secure rubber in place.

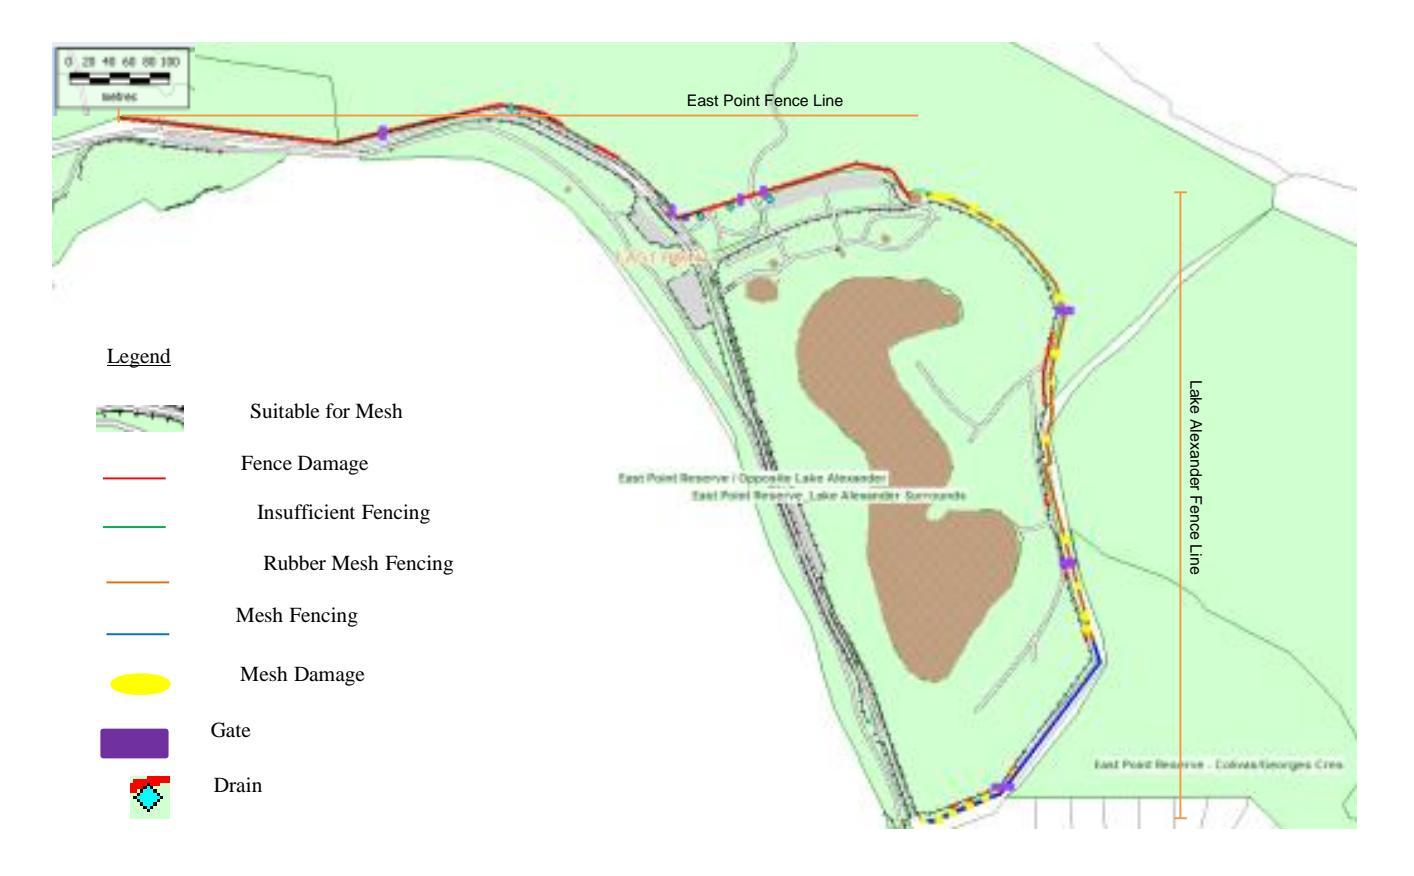
Figure 12 shows mapped fence damage along East Point reserve and Lake Alexander fence line.

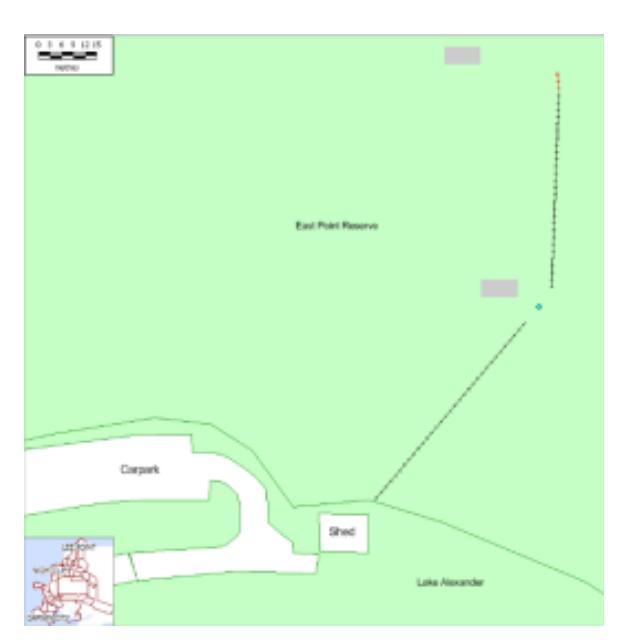
The cane toad fence running approximately 110m in length on the northern side of Lake Alexander shown in Figure 13 is inadequately maintained as illustrated in Figure 10. There is a large drain, possible serving as overflow from Lake Alexander, in the centre of this fence line 10m wide.

Figure 13 is a map showing approximate location of the cane toad fence behind the Lake Alexander shed.

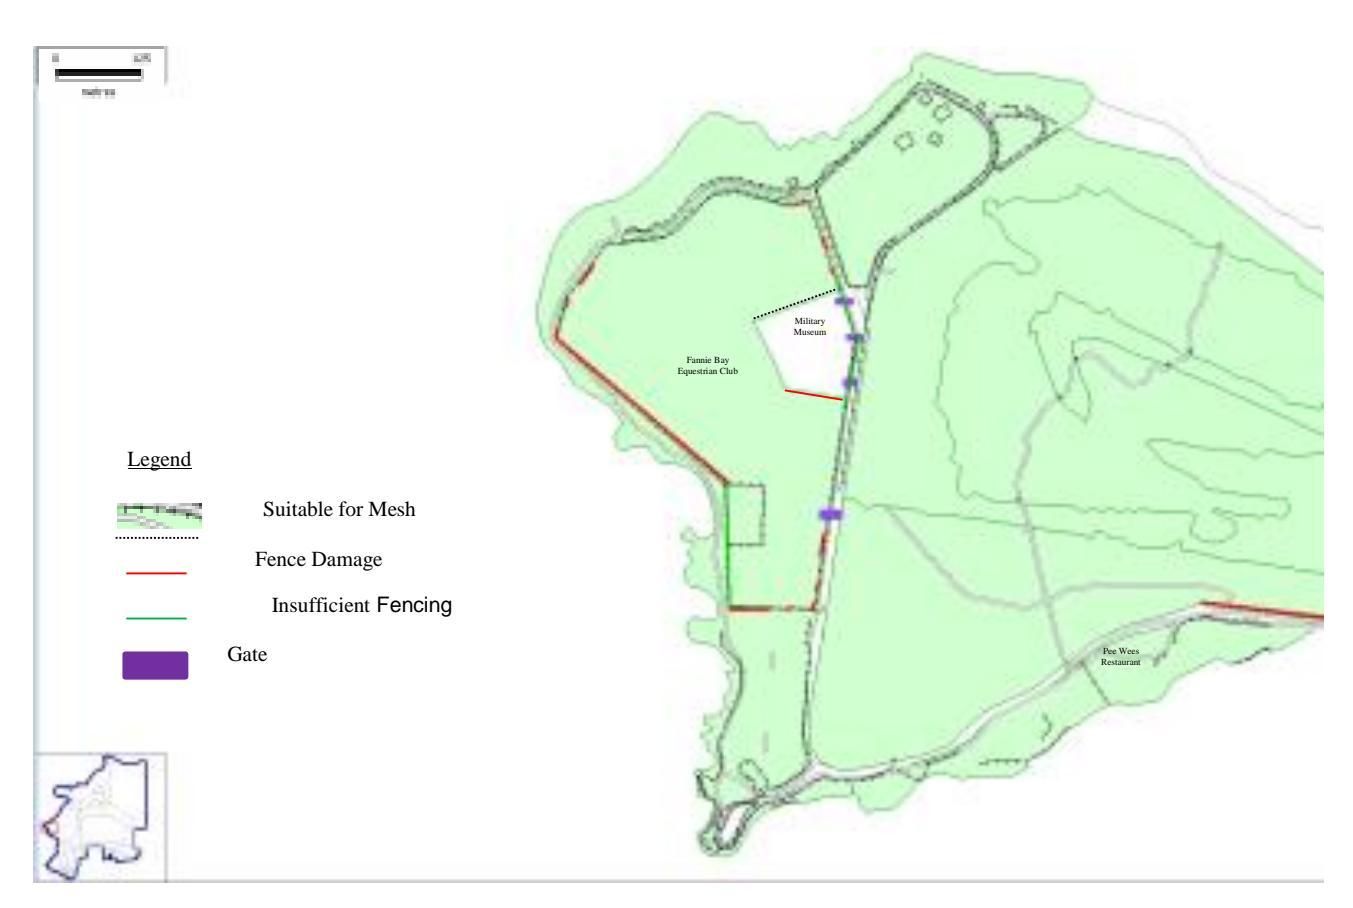
Survey indicated that the boundary of the Fannie Bay Equestrian Club is completely enclosed with suitable fencing for mesh application. As indicated in Figure 14, the western end of the boundary is not well maintained. The Darwin Military Museum has insufficient fencing and 3 main gates that will require modification for mesh application with a fence line boundary running 500m long. The boundary enclosing the Equestrian Club and Military Museum is 1750m long.

Figure 14 with legend shows areas of fence line in need of repair for cane toad exclusion.

It is recommended that the boundary of the Fannie Bay Equestrian Club fence line is applied with mesh and adequately maintained. The fence line is approximately 2km long and only in need of minor sections of repair. The front gate will need specified rubber mesh application re-using the rubber mesh listed and reptile gates installed every 200m along fence line using left over resources from 5.4.

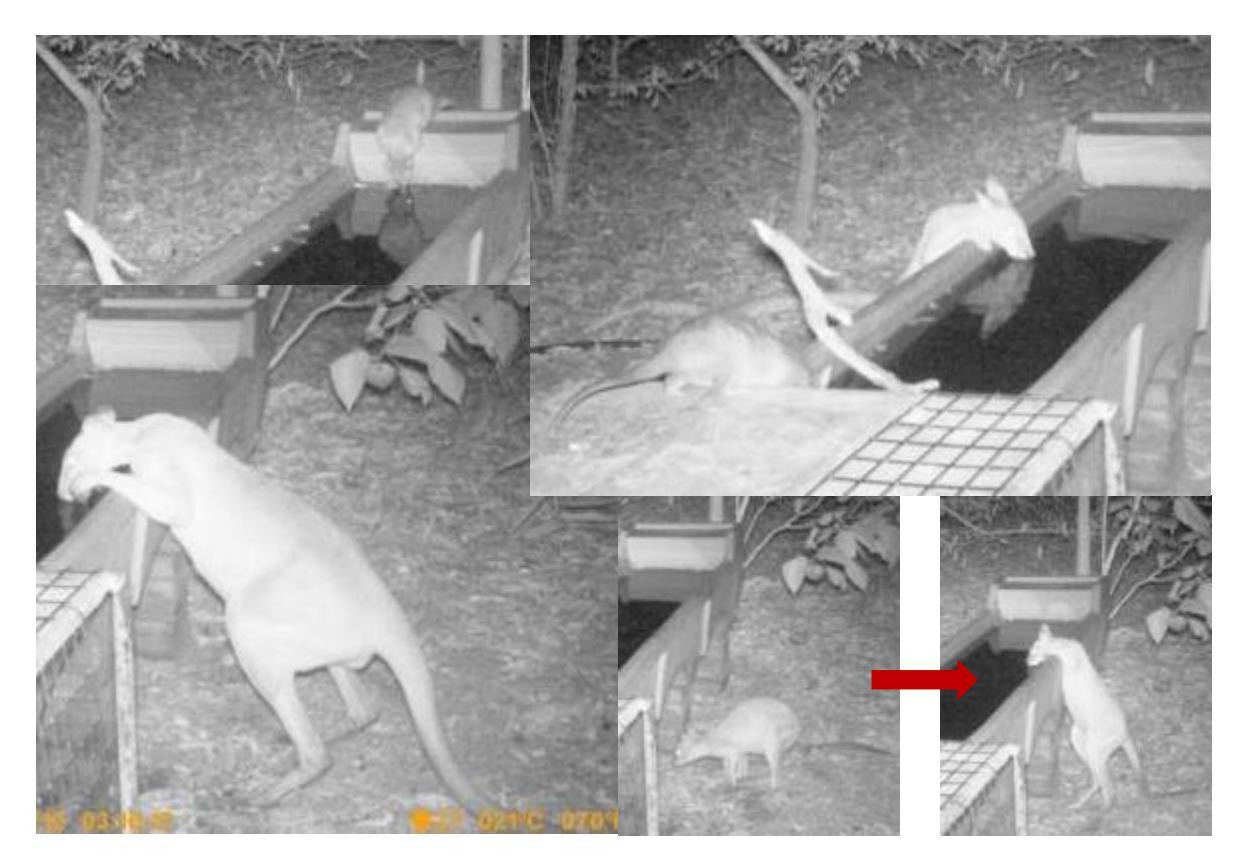
Figure 15 shows on left a male Agile wallaby accessing water on the modified WP, top left possums and wallabies accessing WP and bottom middle and bottom right the size of a presumably female wallaby accessing WP.

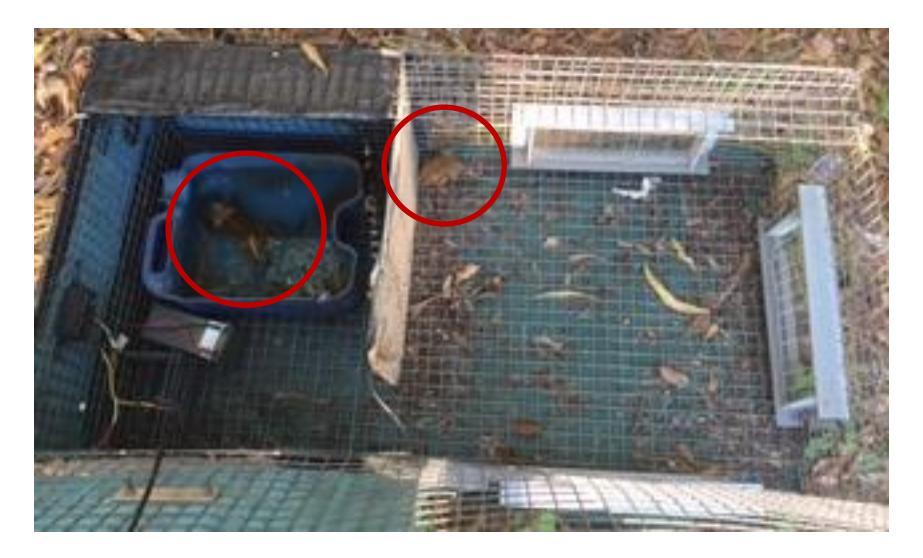
Mr Sawyers' data indicates that the total of 19 cane toads were captured in traps along the Lake Alexander fence line between April- August in 2010 on four occasions. No cane toads were captured on the first evening in either traps and two toads were captured in the WP1 trap (see Figure 20) on the second evening. Two bandicoots were caught in the WP4 trap on the second evening.

Figure 20 shows the successful capture of two cane toads on 12 July 2015 near WP 1.

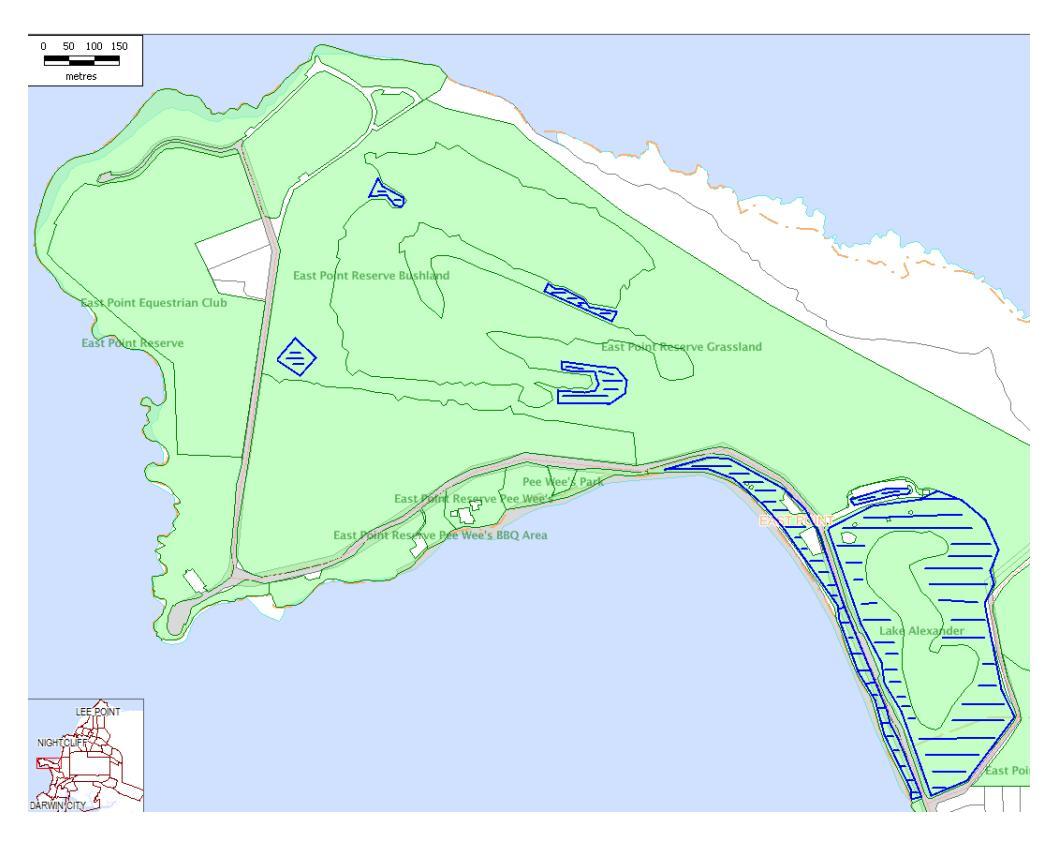
Consultancies with Mr Smith, Mr Grant, Mr Lewis and Assistant Team Leader Central Precinct Martinho Soares, support the shutdown of all irrigation systems within East Point reserve and re-vegetation sites within, Lake Alexander and the roadside recreation area opposite, and confirm it will have minimal effect on vegetation. Grass may cure moderately, although will not cause irreparable damage. Council events booking sheets indicate that there are no upcoming events booked within the region during the proposed period in October, although databases will need to be checked for event booking within a fortnight before shutdown as advised by Senior Climate Change & Environment Officer Jade Leask. It has also been advised from the mentioned City of Darwin employees, that irrigation shut downs could potentially take place more frequently than an annual basis. Figure 21 indicates areas irrigated on a daily basis.

Figure 21 is a map indicating approximate area irrigated within East Point reserve on a daily basis, as directed by Mr Grant.

All irrigation systems within East Point Reserve, Lake Alexander and the recreational area opposite should be shut down for five consecutive days at least twice a year. The first shut down should commence as soon as soil dries from the previous wet season rains. The second shut down should be between September and October when toad populations are strained for hydration.

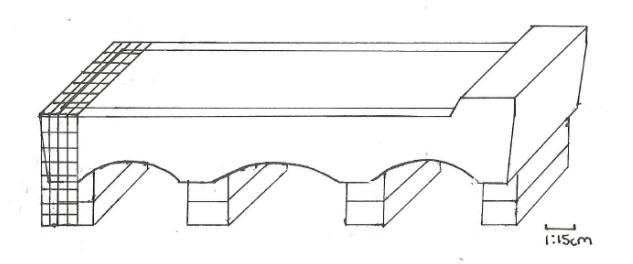
Figure 22 is a scaled diagram of the recommended WP modification for all six remaining WP.

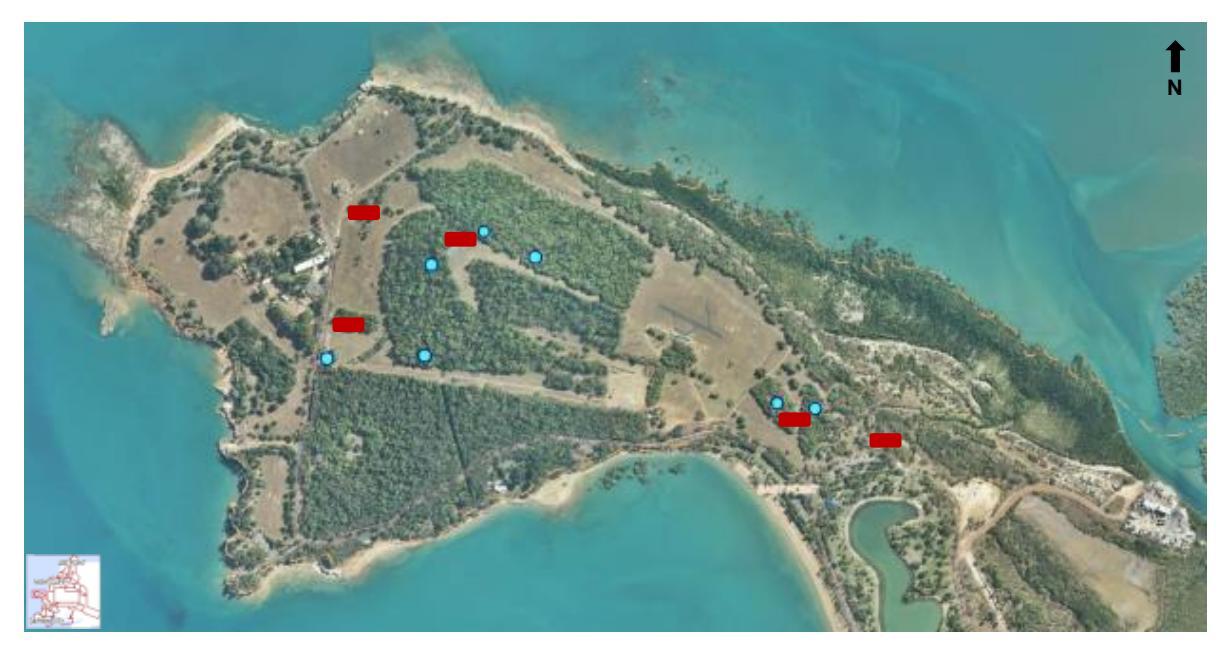
Figure 23 shows a suggested cane toad trap placement strategy.

Figure 23 indicates a recommended cane toad trap placement strategy within East Point reserve. Blue circles show each WP and red rectangles represent cane toad traps.

- Traps be strategically rotated around various WP and irrigation systems within the reserve.
- One trap should remain permanently within 100m of the Northern Lake Alexander drain inside the proposed cane toad fence to capture toads entering the peninsula.
- Traps should be placed in areas of irrigation during the recommended irrigation shut down to lure any surviving toads to capture.
